LeGROS HOME INSPECTIONS

821 Cheshire Drive
Coppell, Texas 75019-5457

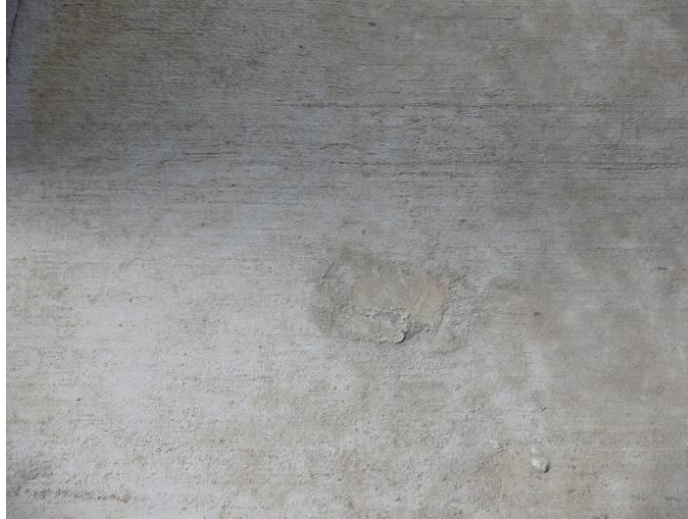
Photo 2: Patches in the patio slab were observed at approximately 10- to 12-foot intervals.

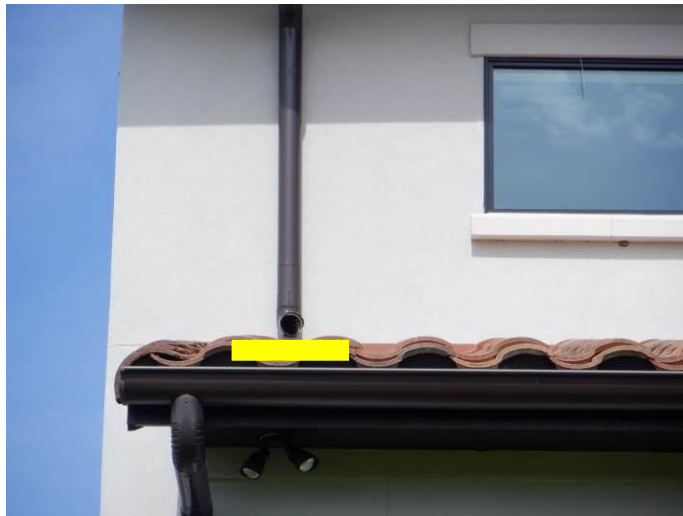
Photo 5: **Splash guards were missing from the gutters in at least two locations on the rear (east) side of the roof over the patio.**

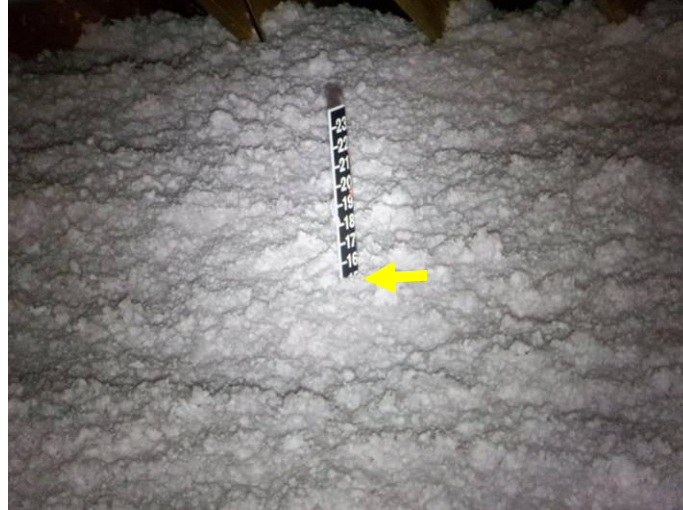
Photo 6: Lower areas of insulation were noted in the southeast portion of the uppermost attic.

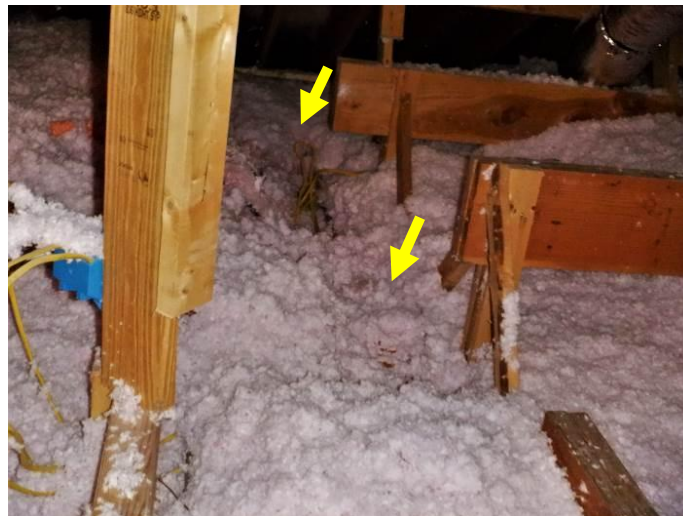
Photo 7: Lower areas of insulation were noted in the southeast portion of the uppermost attic.

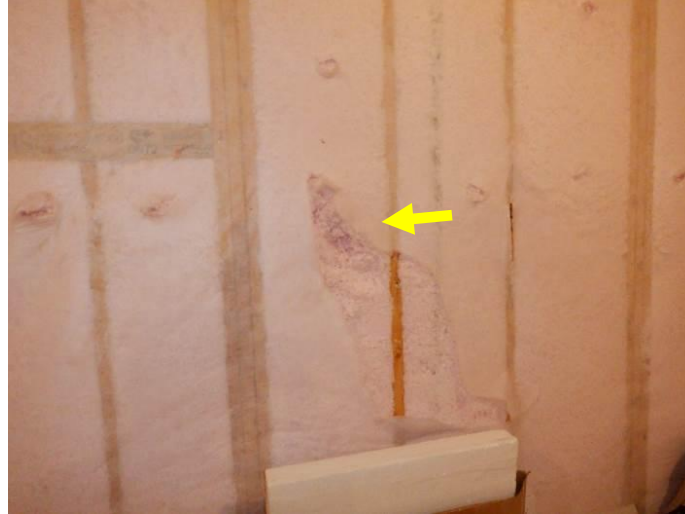
Photo 8: Some holes were noted in the insulation where exposed in the unfinished storage area.

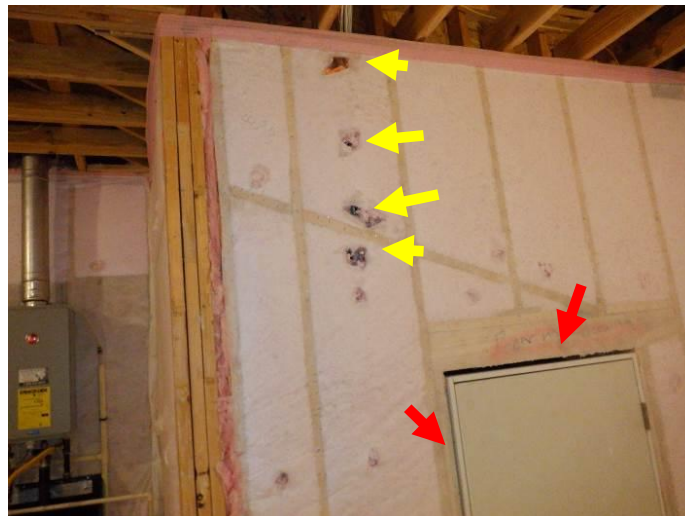
Photo 9: Some holes were noted in the insulation where exposed in the unfinished storage area. The perimeter of the attic access door in the north wall of the unfinished storage room was not adequately insulated (red arrows).

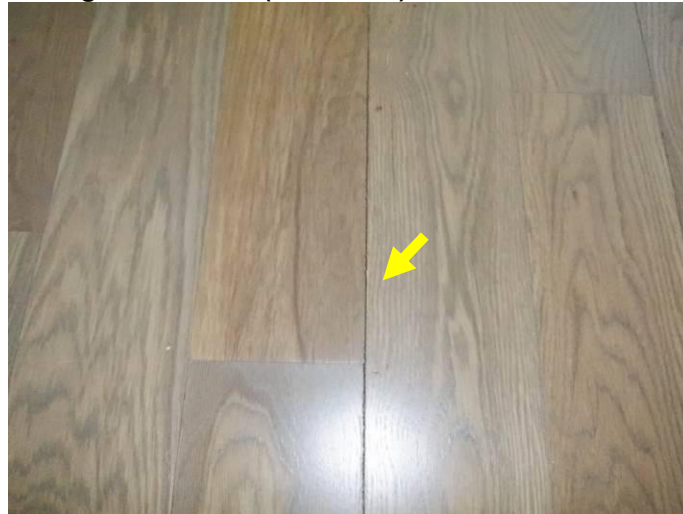
Photo 10: A noticeable gap was noted in the wood flooring in at least one location in the upper hall.

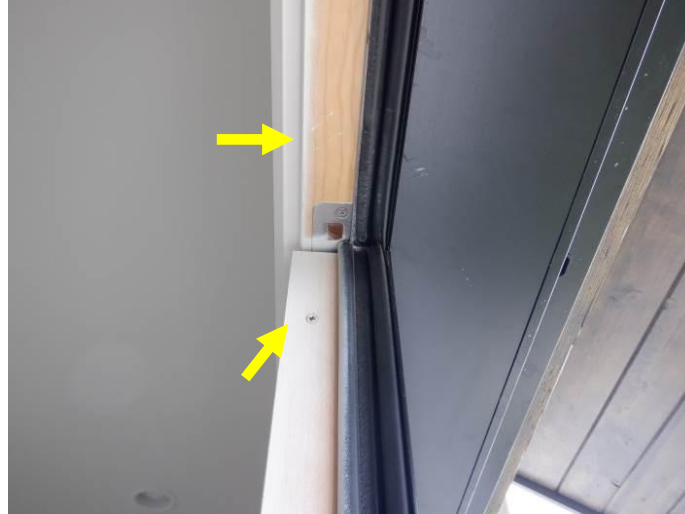
Photo 11: The painting of the upper balcony doors in the northwest bedroom was incomplete.

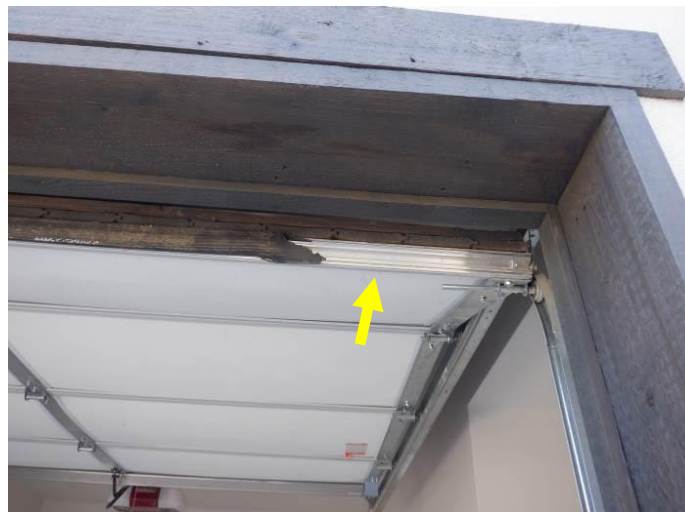
Photo 12: The bottom gaskets were damaged on both overhead garage doors (single door is shown).

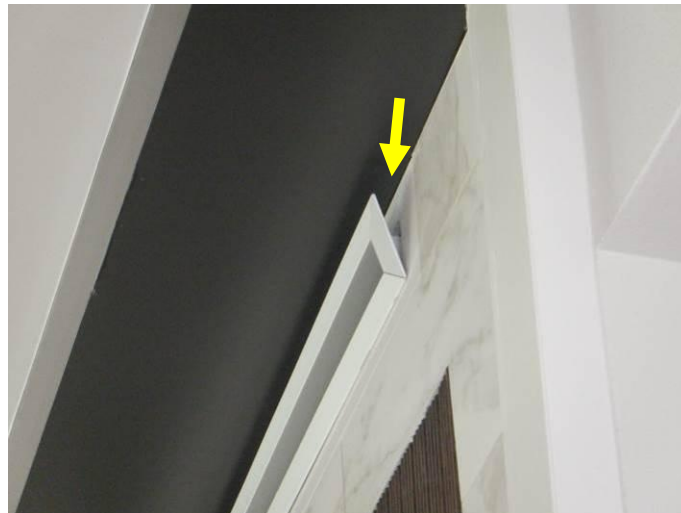
Photo 15: **The trim kit for the fireplace blower was not secured.**

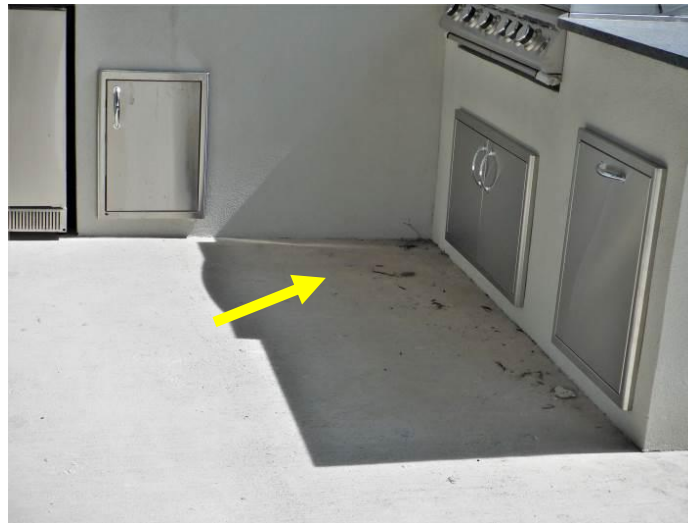
Photo 16: A water entrapment condition was noted at the outdoor kitchen area.

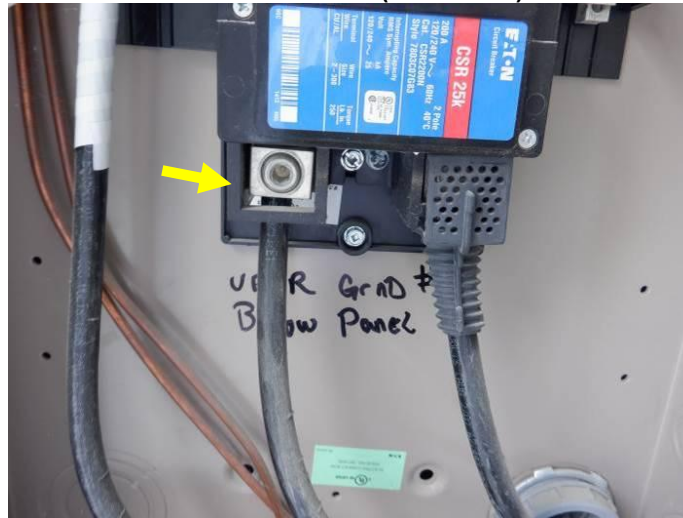
Photo 17: **No barrier or cover was noted on one of the two service entrance terminals in the westernmost panelboard.**

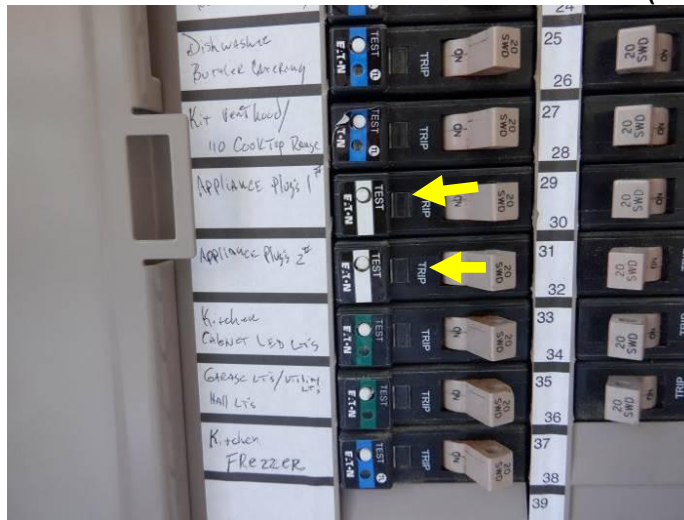
Photo 18: No arc-fault protection was noted for the two countertop appliance circuits for the kitchen counters, although GFCI protection was present.

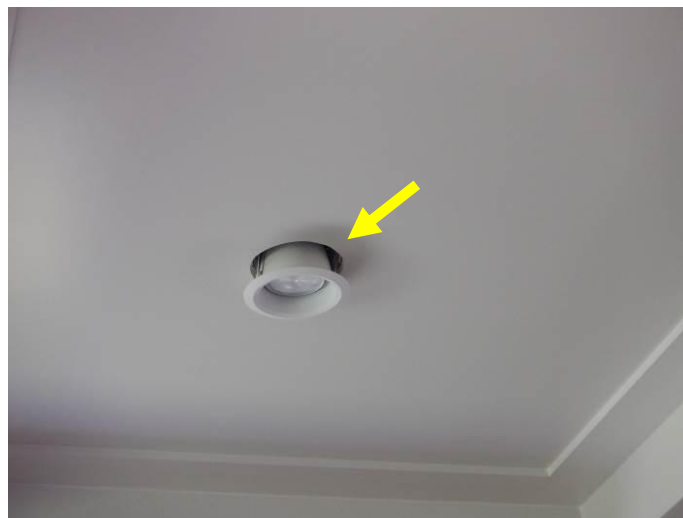
Photo 19: An unsecured trim ring was noted at one can light fixture in the upper game room.

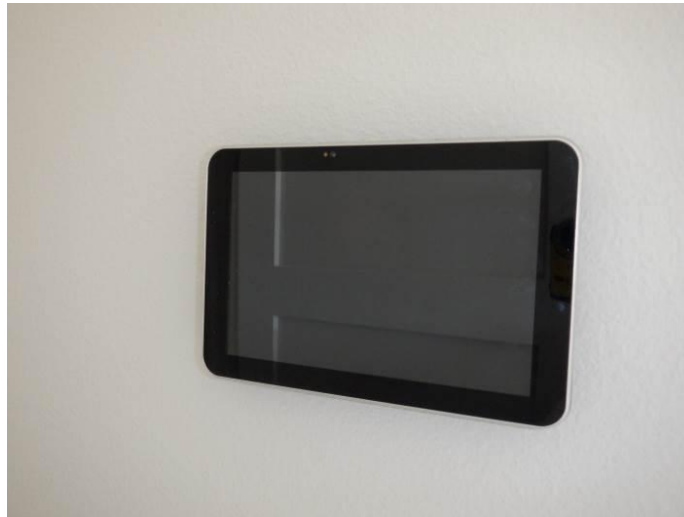
Photo 20: The thermostat for this system was found blank and unresponsive.

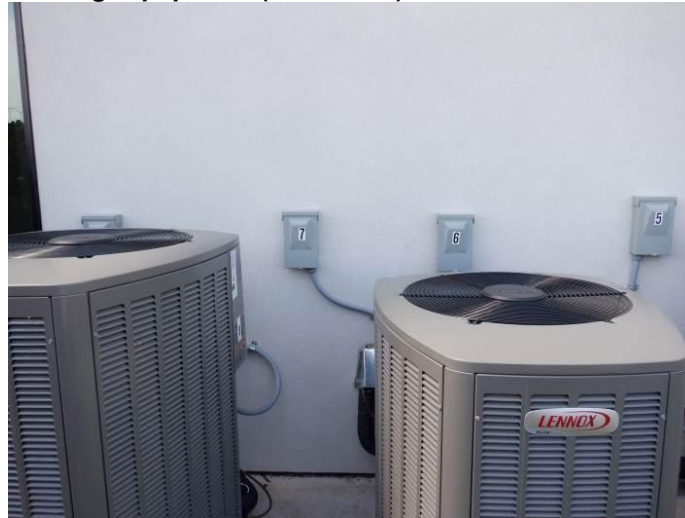
Photo 21: The services disconnect panels for two exterior condensing units were located behind the condensing units.

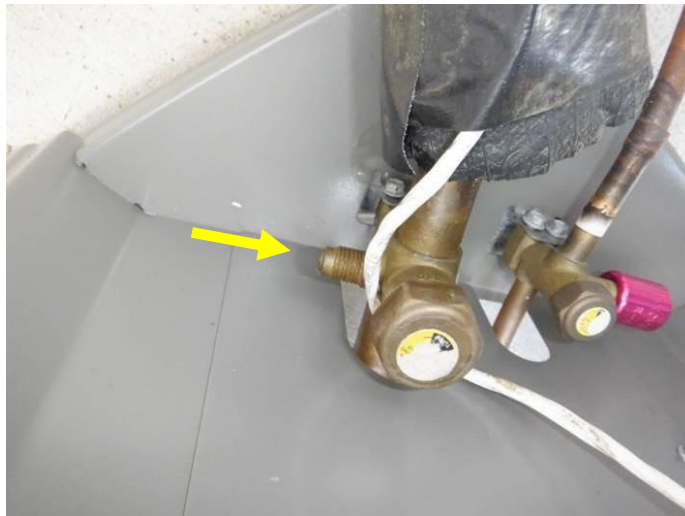
Photo 22: A safety cap was missing from the refrigerant line on the master bedroom condensing unit.

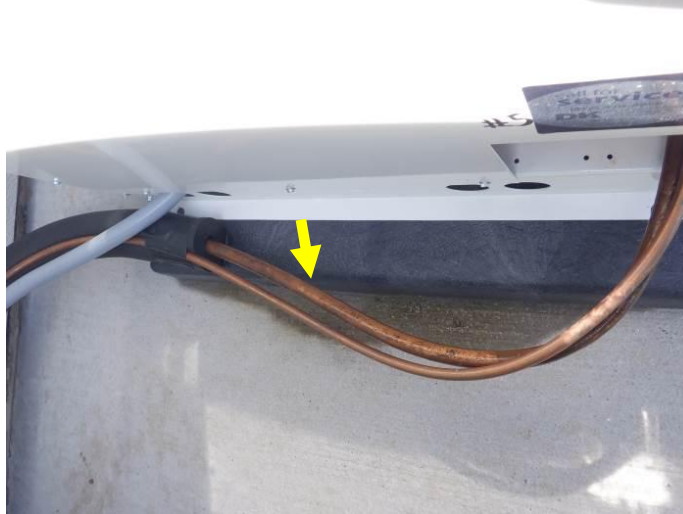
Photo 23: A portion of the suction line insulation was missing from the Emerson condensing unit

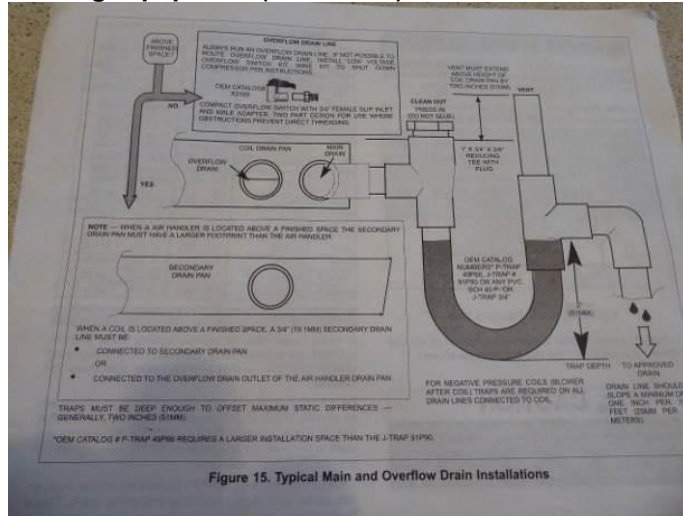
Photo 26: A trap with a depth no less than two inches (2”) is recommended for positive-pressure (blow-through) systems to prevent air from blowing through the trap seal (stock photo).

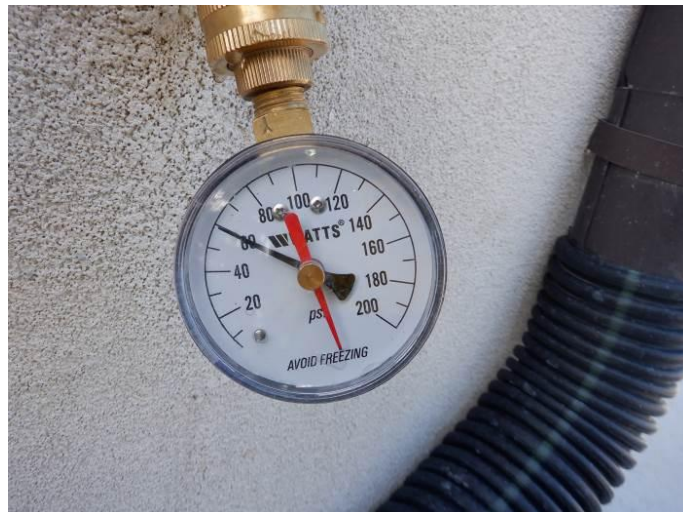
Photo 28: A water pressure of approximately 60 psi (pounds per square inch) was measured at the north exterior faucet.

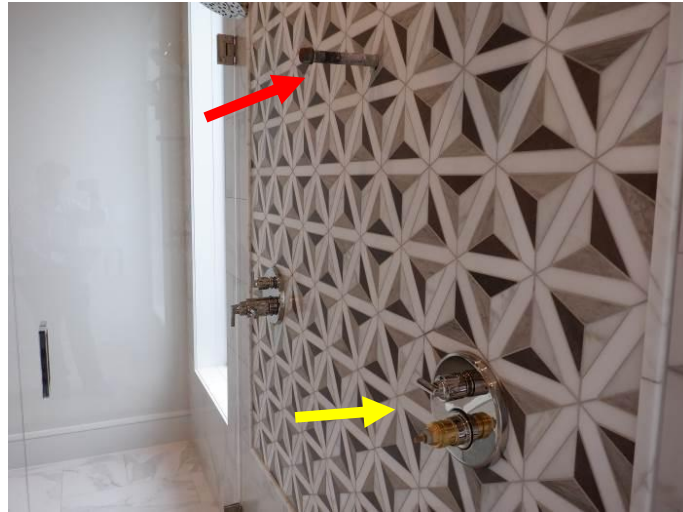
Photo 30: The easternmost shower valve installation was incomplete (yellow arrow). The wand fixture for the westernmost shower diverter was not installed (red arrow).

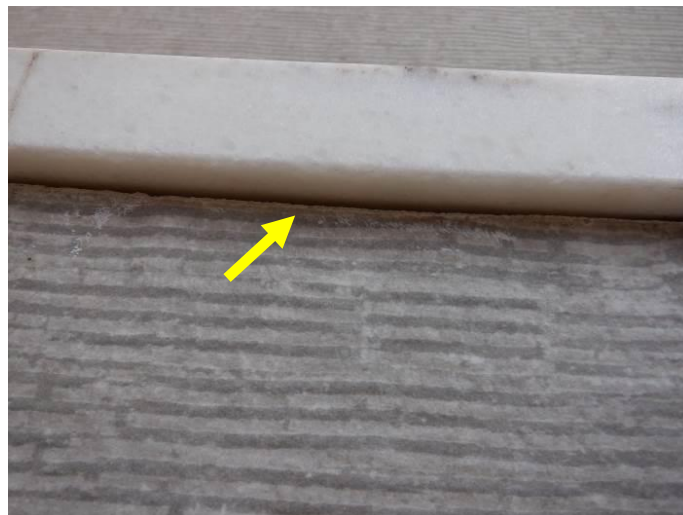
Photo 31: The caulking was incomplete beneath the shower bench. (Continued)

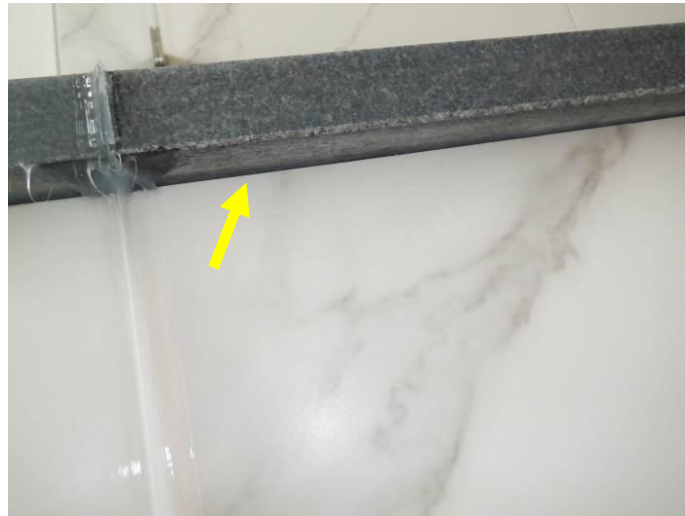
Photo 32: **The caulking was incomplete beneath the shower bench.**

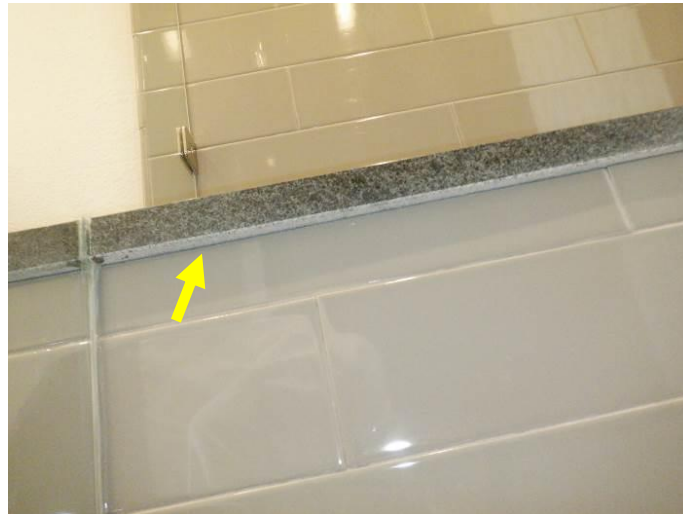
Photo 33: The underside of the bench and curb cap were not caulked (bench is shown).

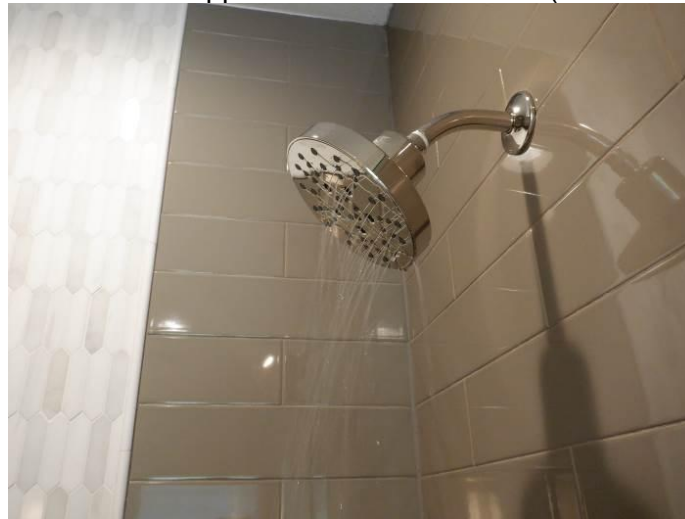
Photo 34: **Very poor water flow was noted at the shower head.**

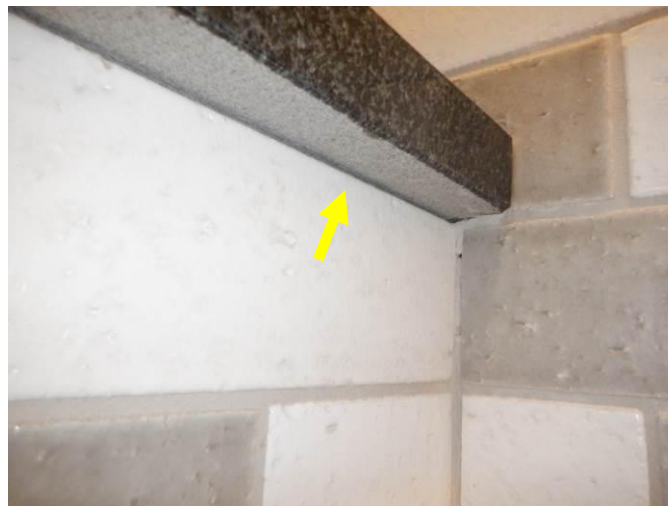
Photo 35: **The undersides of the bench and the curb cap were not caulked (shower bench is shown).**

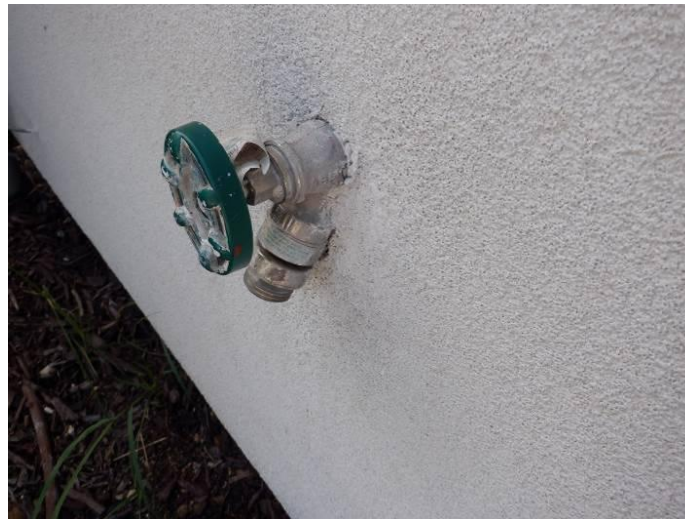
Photo 36: All exterior faucets were embedded into the stucco (north side is shown).

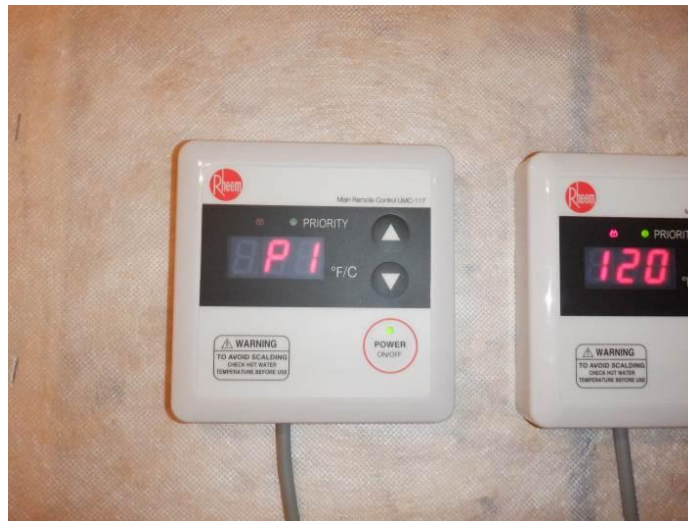
Photo 40: The water heaters would not remain activated and "P-1" codes flashed on both thermostat control pads (westernmost unit).

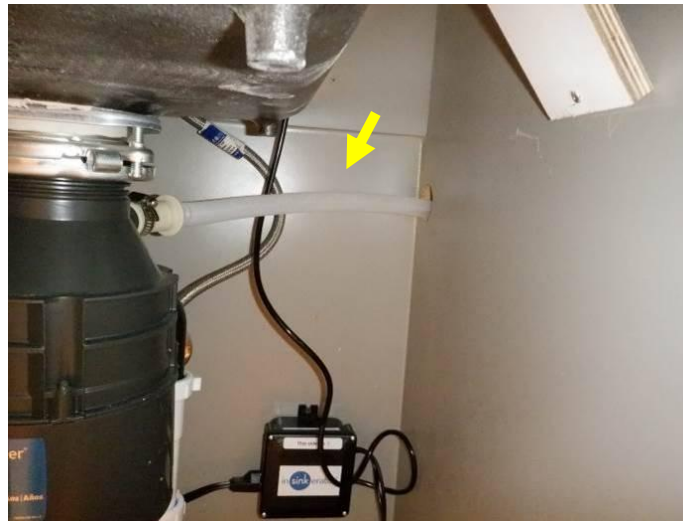
Photo 42: No adequate anti-siphon loop or air gap fixture was present in the dishwasher drain line in the butler's pantry.

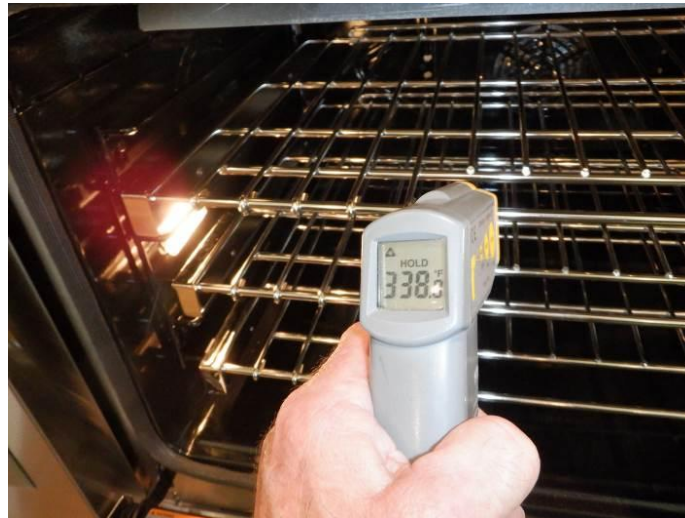
Photo 44: The right oven cycled normally. The right oven registered approximately 338°F when set on 350°F after a 30-minute preheating time.

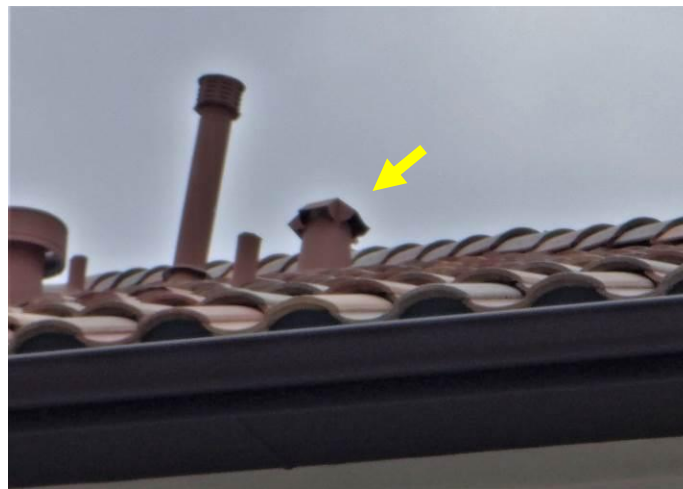
Photo 45: The exhaust duct discharged through an exhaust terminal without a backdraft damper.

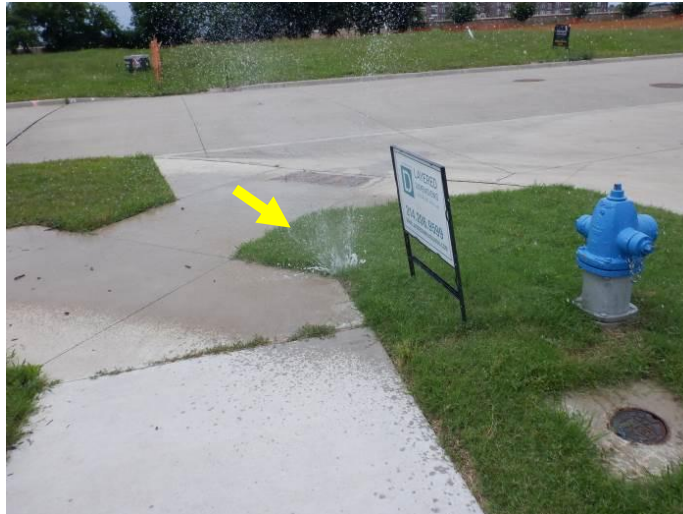
Photo 46: At least one leak was noted at the south end of the parkway.
