LeGROS HOME INSPECTIONS

821 Cheshire Drive
Coppell, Texas 75019-5457

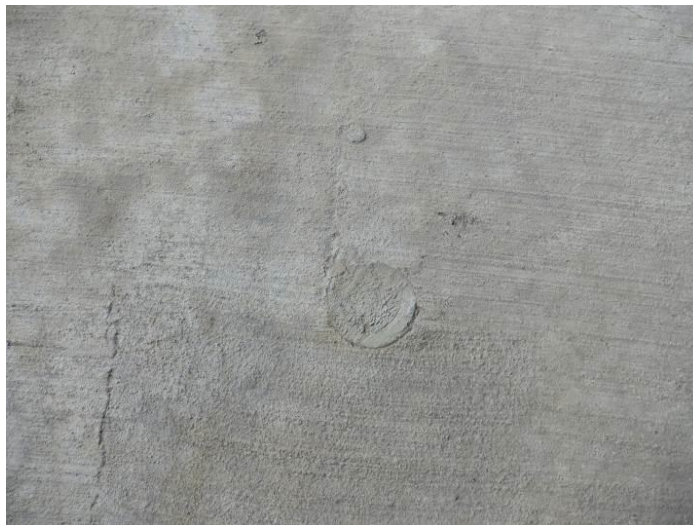
Photo 1: Patches in the patio slab were observed at approximately 10- to 12-foot intervals.

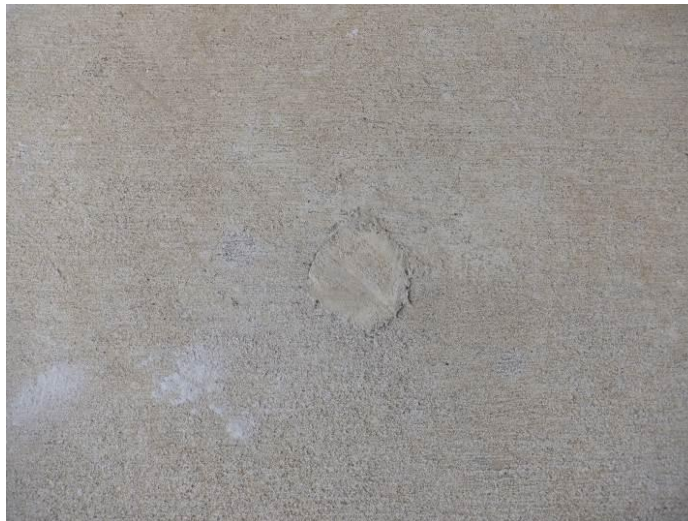
Photo 3: Patches in the patio slab were observed at approximately 10- to 12-foot intervals.

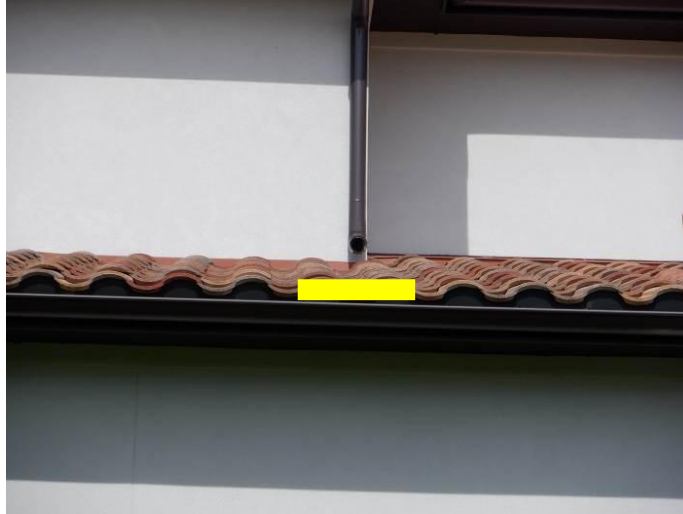
Photo 4: Splash guards were missing from the gutters in at least two locations on the rear (east) side of the roof over the patio.

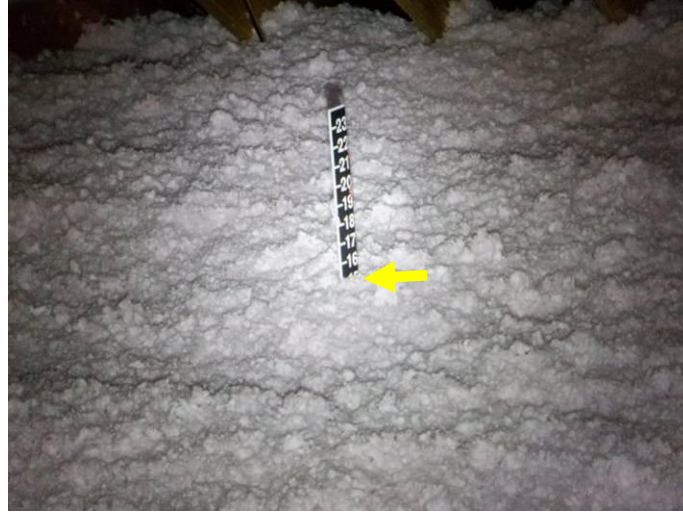
Photo 6: Lower areas of insulation were noted in the southeast portion of the uppermost attic.

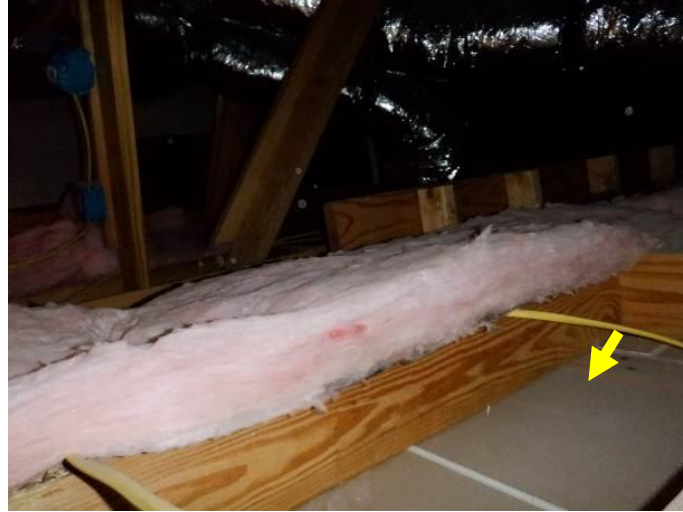
Photo A: No insulation was observed along the south perimeter of the attic space over the lower guest bathroom and closet as observed via camera from the temporary opening in the ceiling of the lower guest closet (at the access opening).

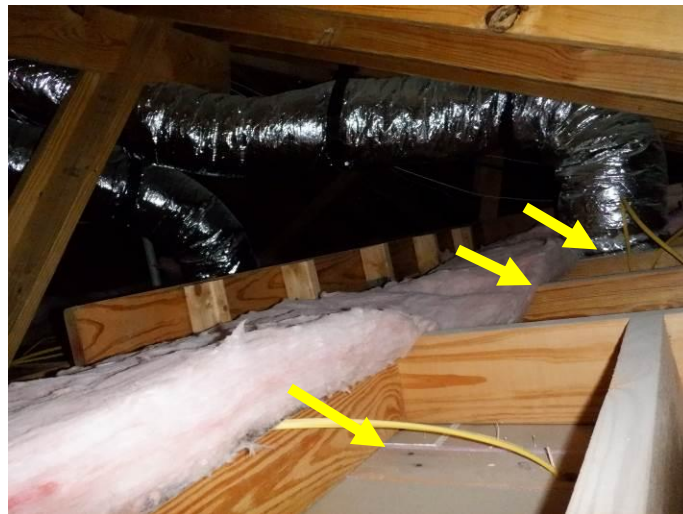
Photo B: No insulation was observed along the south perimeter of the attic space over the lower guest bathroom and closet as observed via camera from the temporary opening in the ceiling of the lower guest closet (east of the opening).

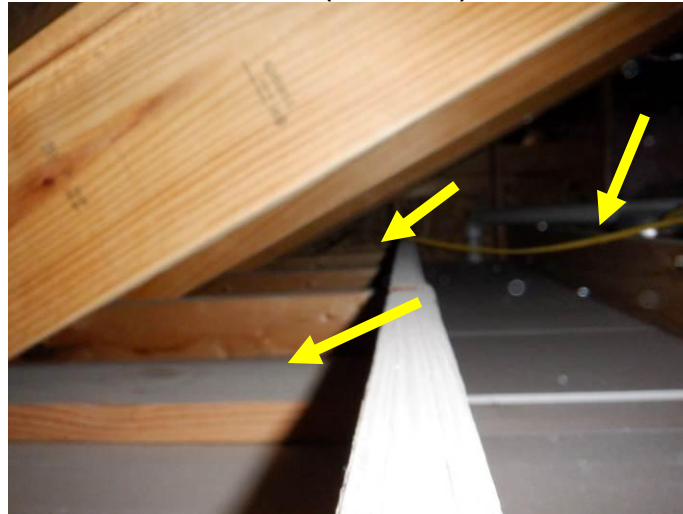
Photo C: No insulation was observed along the south perimeter of the attic space over the lower guest bathroom and closet as observed via camera from the temporary opening in the ceiling of the lower guest closet (west of the opening).

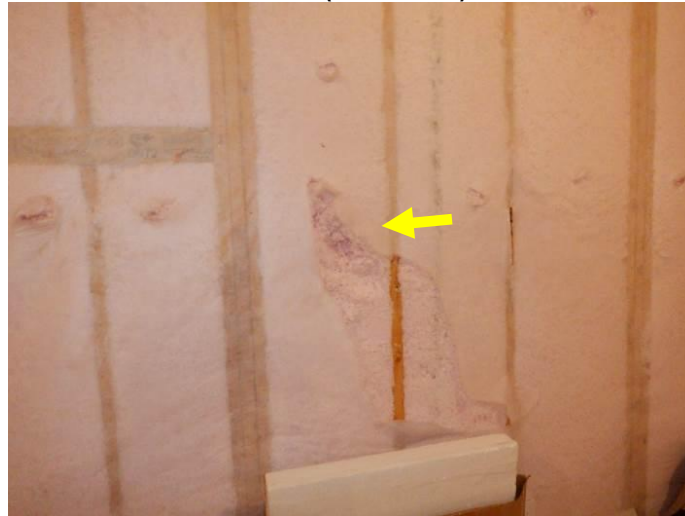
Photo 8: Some holes were noted in the insulation where exposed in the unfinished storage area.

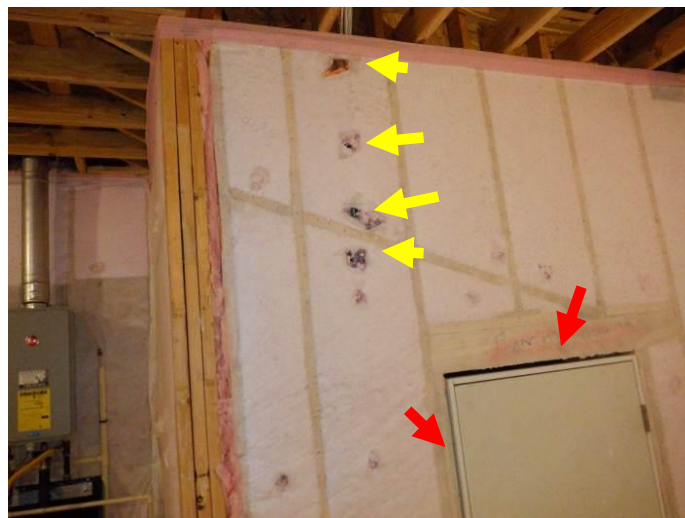
Photo 9: Some holes were noted in the insulation where exposed in the unfinished storage area. The perimeter of the attic access door in the north wall of the unfinished storage room was not adequately insulated (red arrows).

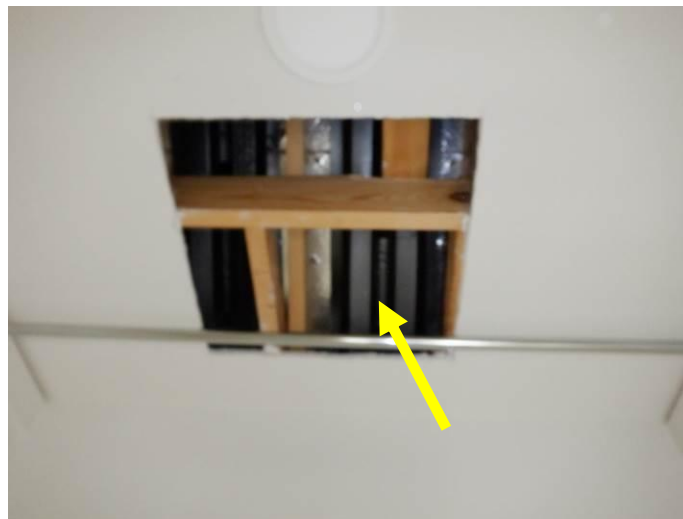
Photo D: A temporary opening was observed in the ceiling of the guest bathroom closet.

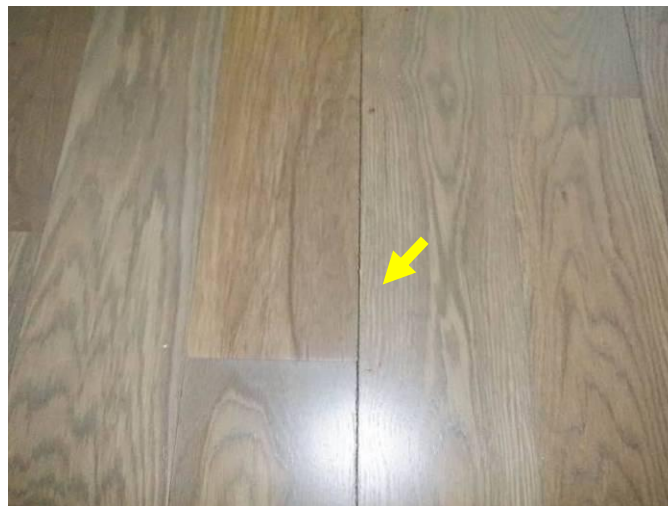
Photo 10: A noticeable gap was noted in the wood flooring in at least one location in the upper hall.

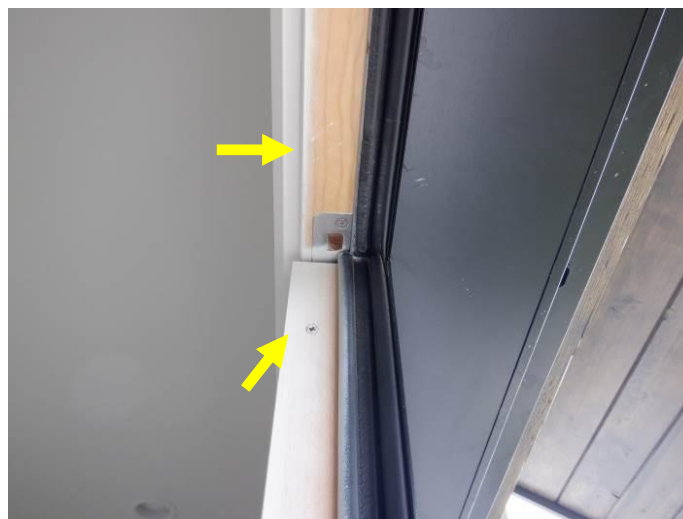
Photo 11: The painting of the upper balcony doors in the northwest bedroom was incomplete.

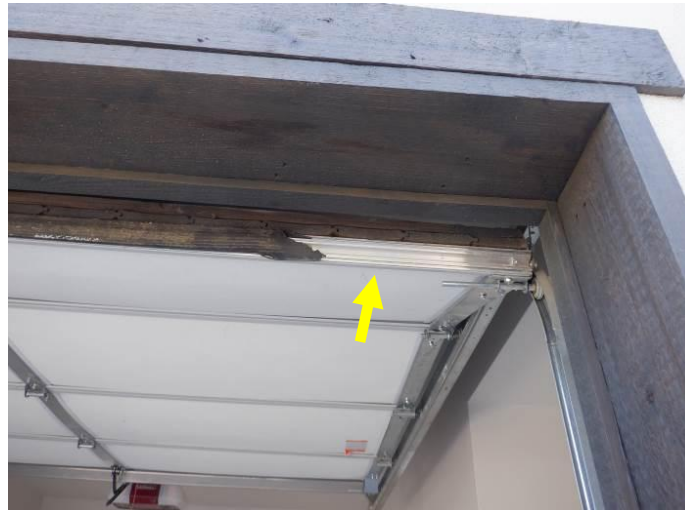
Photo 12: The bottom gaskets were damaged on both overhead garage doors (single door is shown).

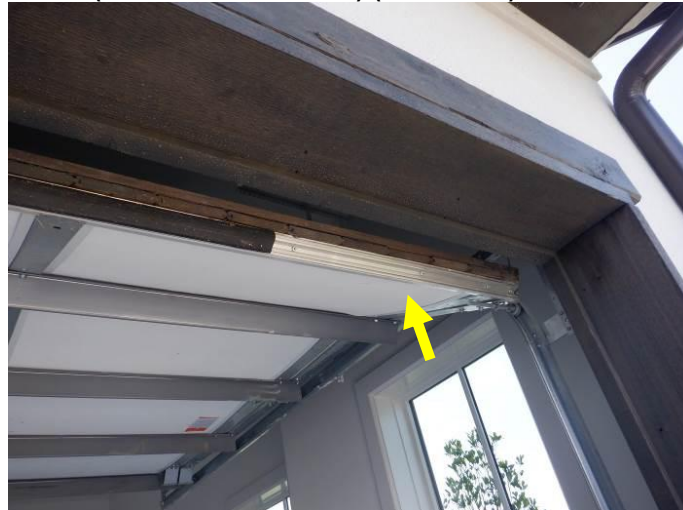
Photo 13: The bottom gaskets were damaged on both overhead garage doors (double garage door is shown).

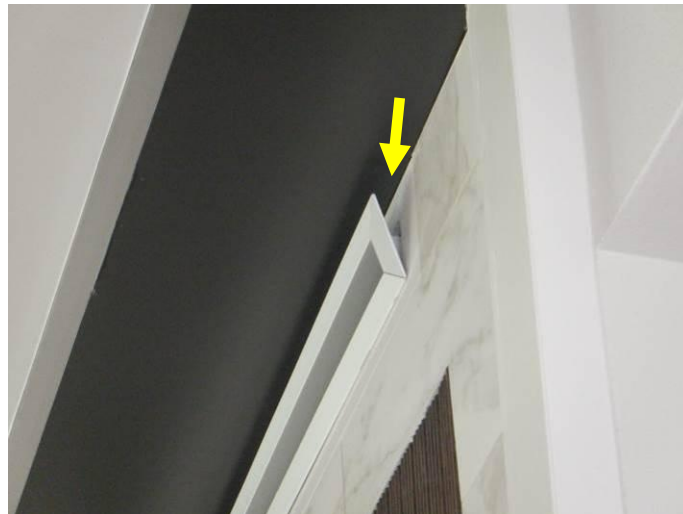
Photo 15: The trim kit for the fireplace blower was not secured.

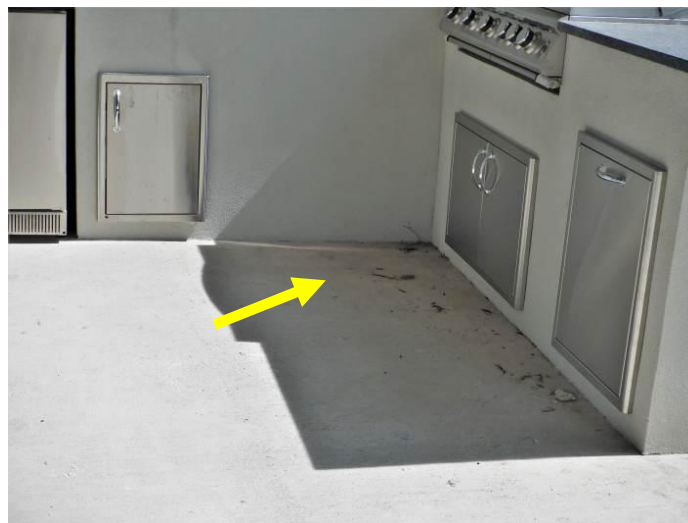
Photo 16: A water entrapment condition was noted at the outdoor kitchen area.

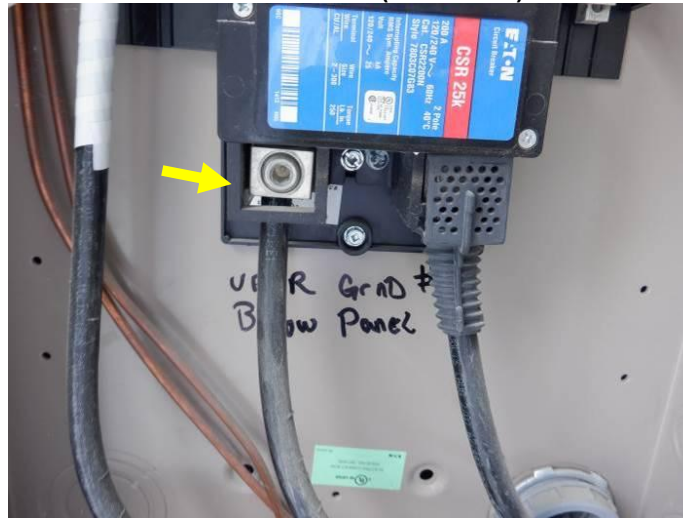
Photo 17: No barrier or cover was noted on one of the two service entrance terminals in the westernmost panelboard.

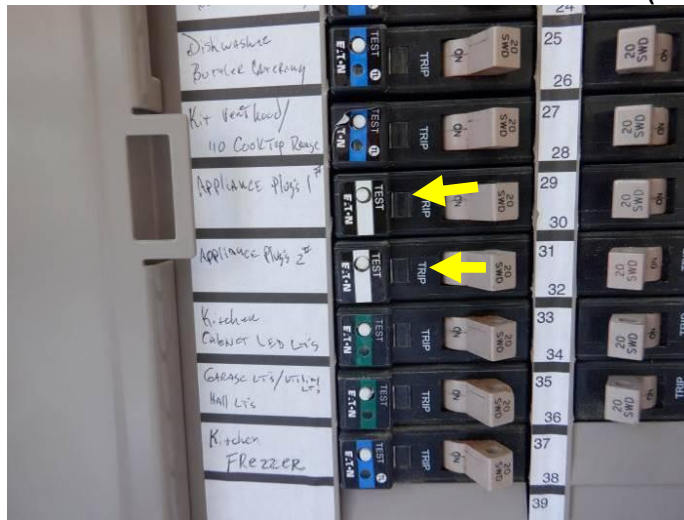
Photo 18: No arc-fault protection was noted for the two countertop appliance circuits for the kitchen counters, although GFCI protection was present.

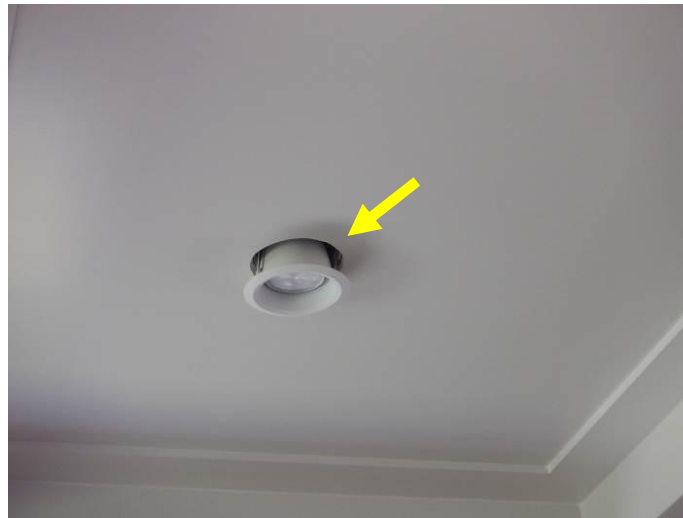
Photo 19: An unsecured trim ring was noted at one can light fixture in the upper game room.
(Continued)

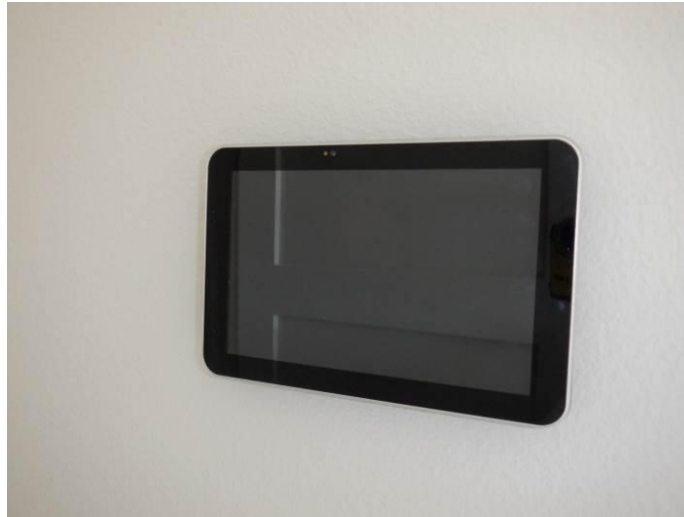
Photo 20: The thermostat for this system was found blank and unresponsive.

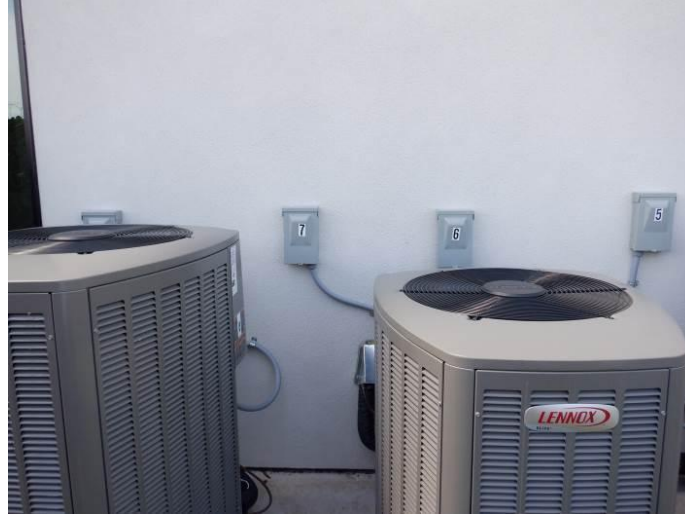
Photo 21: The services disconnect panels for two exterior condensing units were located behind the condensing units.

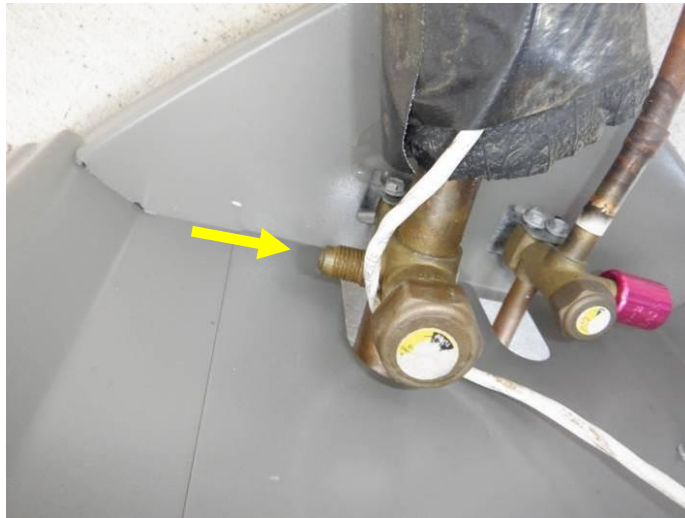
Photo 22: A safety cap was missing from the refrigerant line on the master bedroom condensing unit.

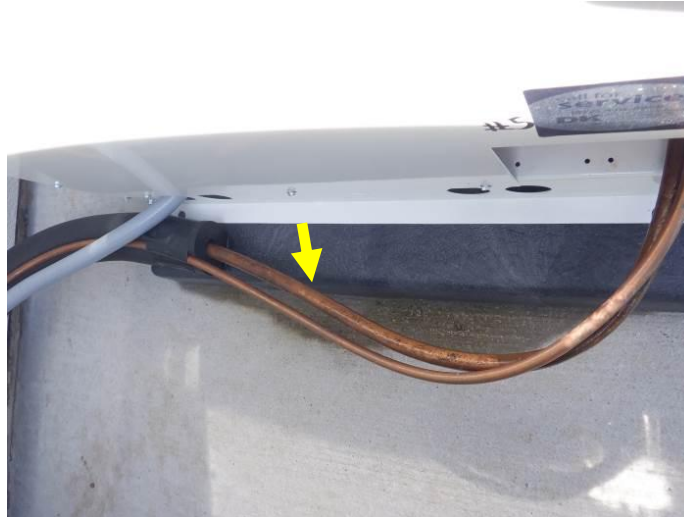
Photo 23: A portion of the suction line insulation was missing from the Emerson condensing unit.

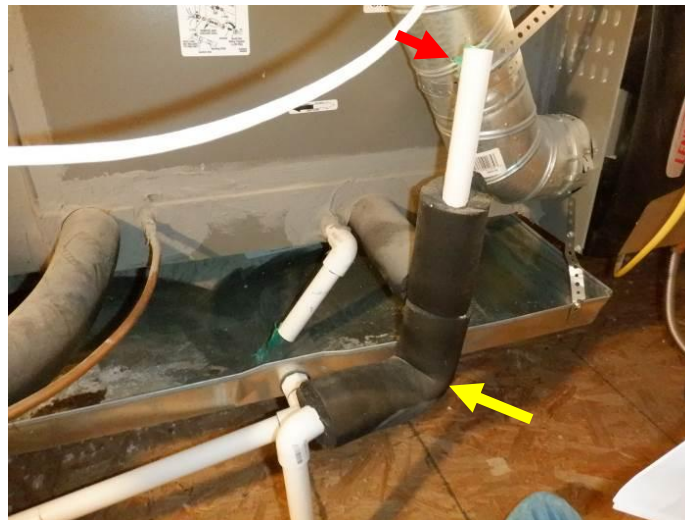
Photo 24: The P-trap (yellow arrow) was installed on the downstream side of the vent pipe (red arrow) for the primary condensate drain line of each HVAC system (master bedroom unit is shown).

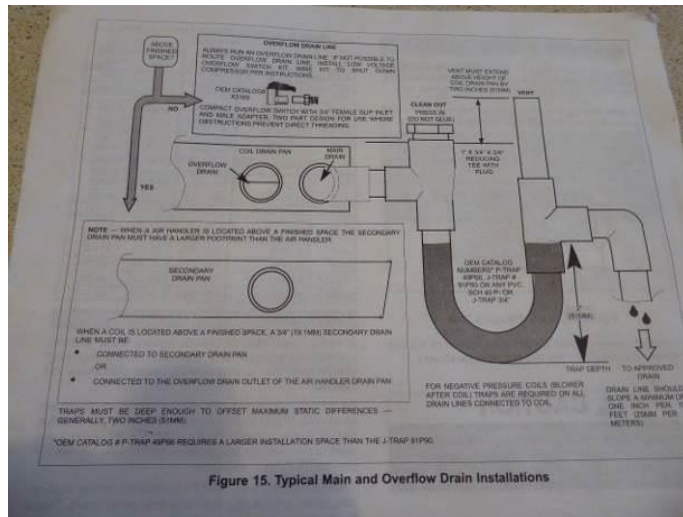
Photo 26: A trap with a depth no less than two inches (2") is recommended for positive-pressure (blow-through) systems to prevent air from blowing through the trap seal (stock photo).

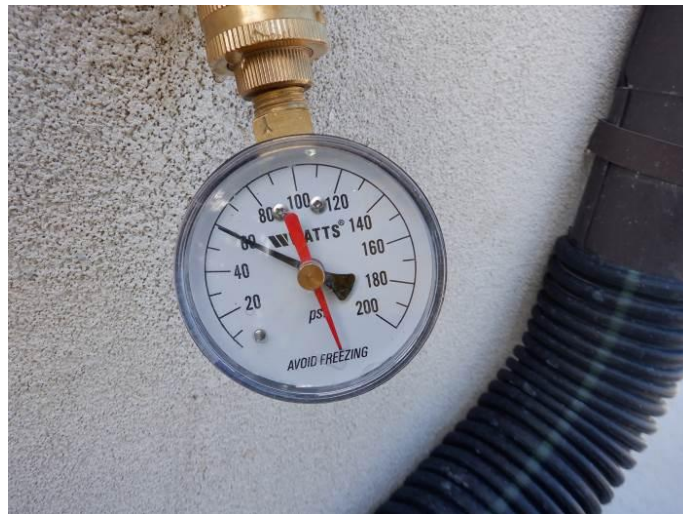
Photo 28: A water pressure of approximately 60 psi (pounds per square inch) was measured at the north exterior faucet.

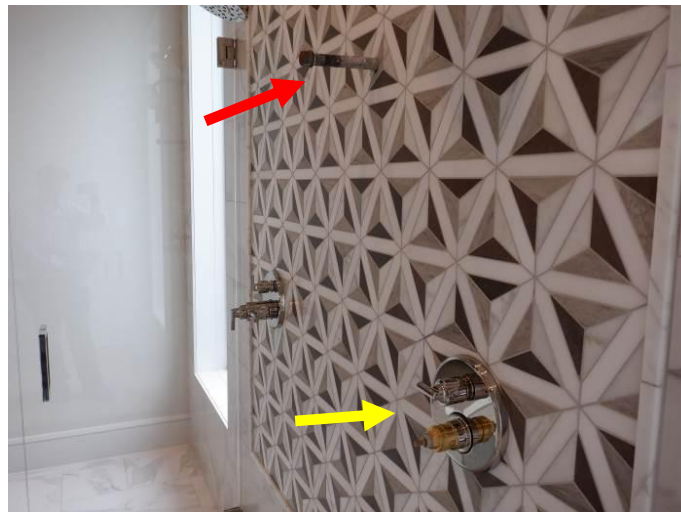
Photo 30: The easternmost shower valve installation was incomplete (yellow arrow). The wand fixture for the westernmost shower diverter was not installed (red arrow).

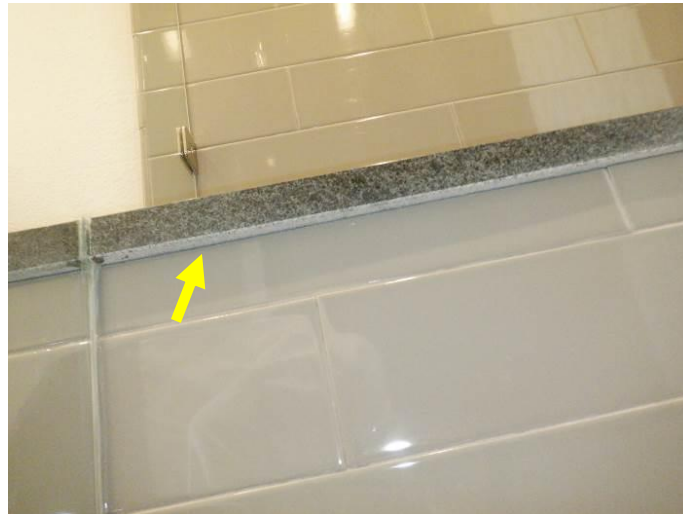
Photo 33: The underside of the bench and curb cap were not caulked (bench is shown).

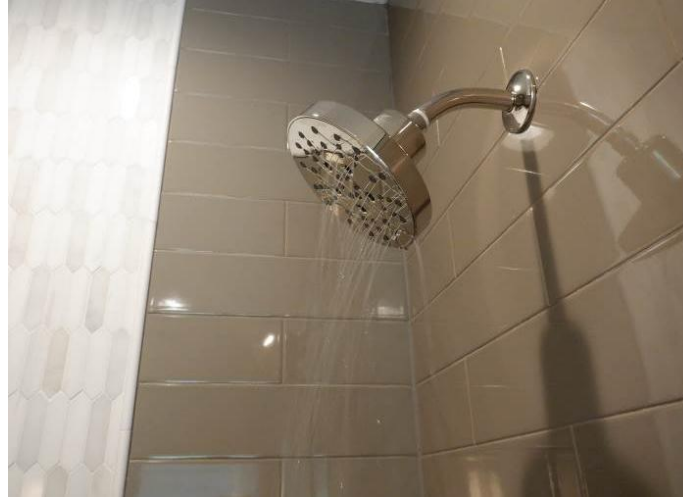
Photo 34: Very poor water flow was noted at the shower head.

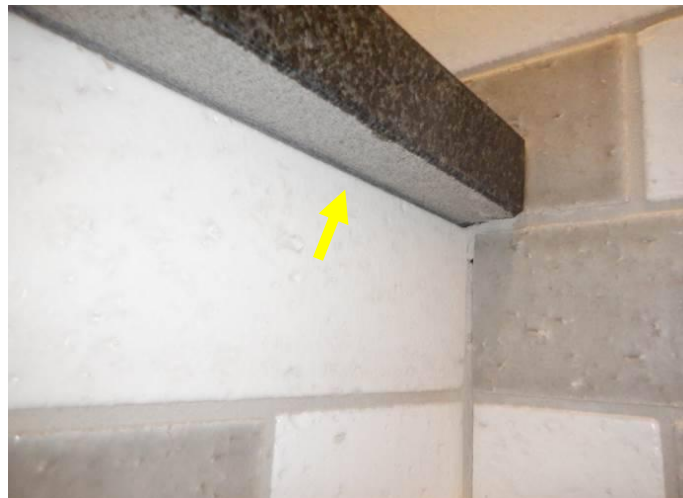
Photo 35: The undersides of the bench and the curb cap were not caulked (shower bench is shown).

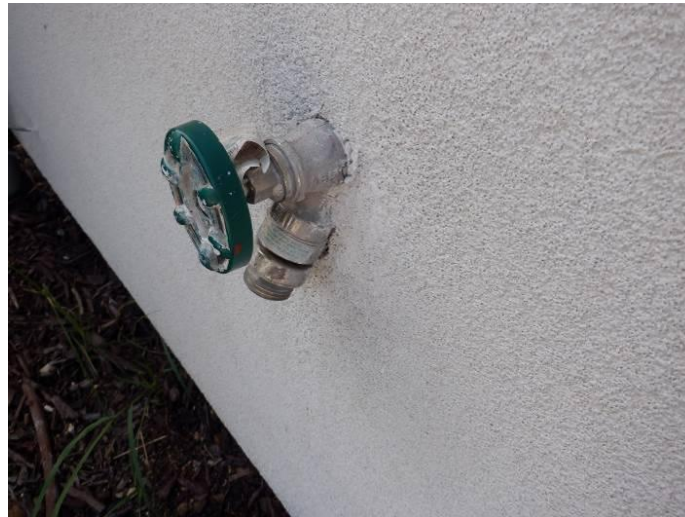
Photo 36: All exterior faucets were embedded into the stucco (north side is shown).

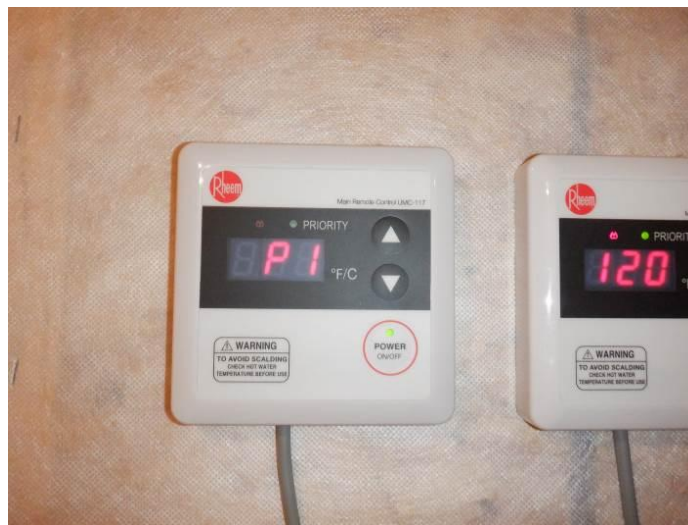
Photo 40: The water heaters would not remain activated and “P-1” codes flashed on both thermostat control pads (westernmost unit).

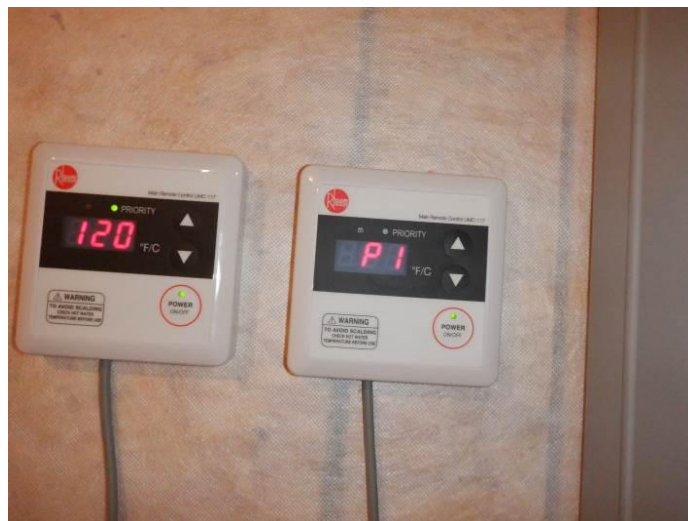
Photo 41: The water heaters would not remain activated and “P-1” codes flashed on both thermostat control pads (easternmost unit).

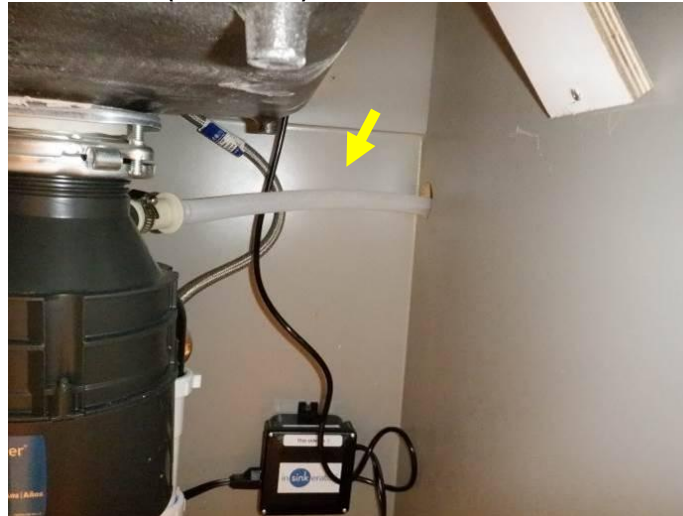
Photo 42: No adequate anti-siphon loop or air gap fixture was present in the dishwasher drain line in the butler's pantry.

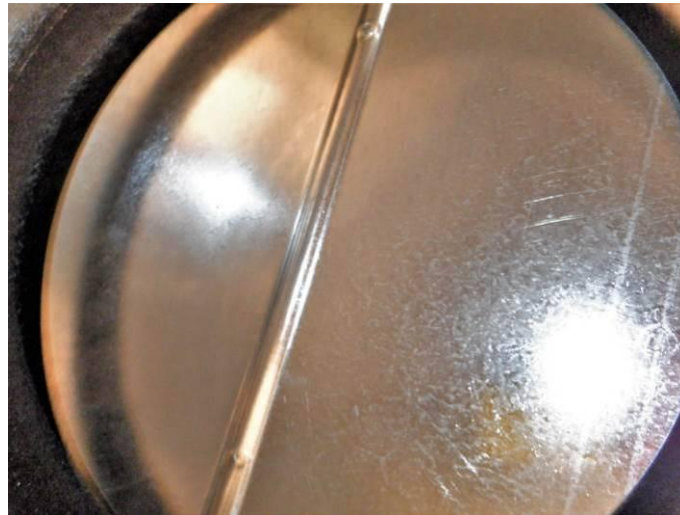
Photo A: The automatic damper did not open when the exhaust hood was activated on high speed (photo of the damper when the range vent was activated).

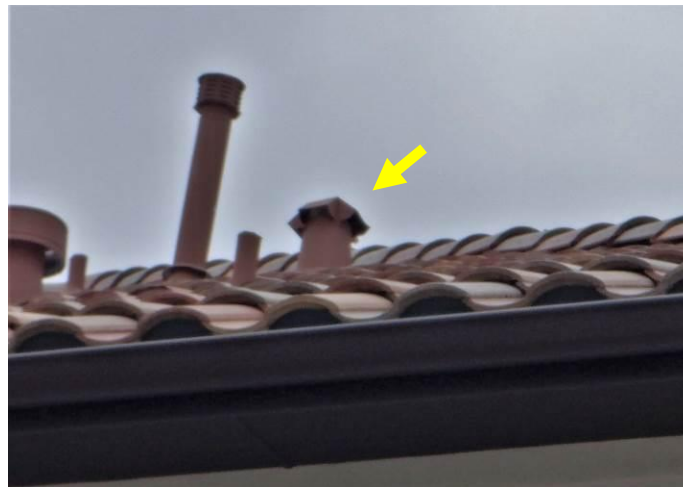
Photo 45: The exhaust duct discharged through an exhaust terminal without a backdraft damper.

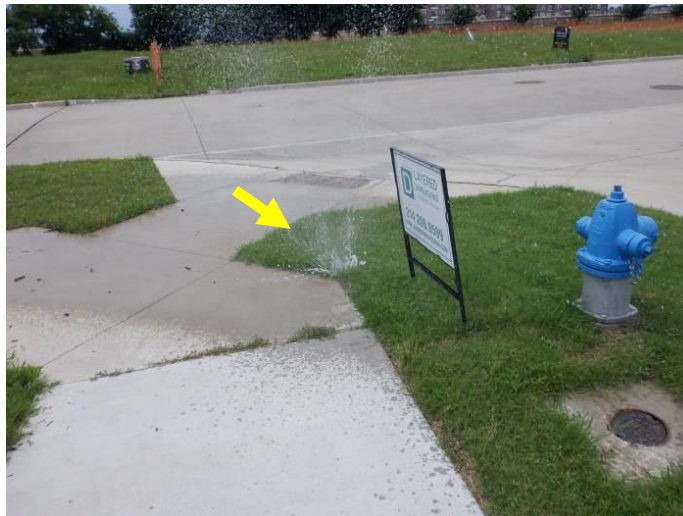
Photo 46: At least one leak was noted at the south end of the parkway.
