Single Family Residence

PROPERTY INSPECTION REPORT

Concerning: 4144 Shady Bend Drive, Dallas, TX 75244
(Address or Other Identification of Inspected Property)

By: Clyde (Butch) Gayoso, Lic #5891 05/26/2020
(Name and License Number of Inspector) (Date)

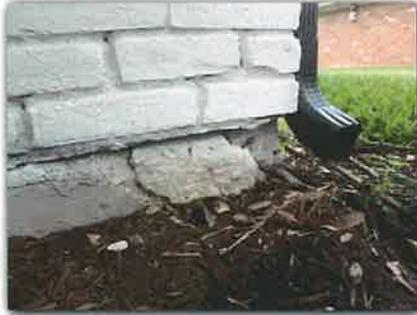
Need to patch the foundation corners with hydraulic mortar/cement where they have cracked. This is a common occurrence and does not affect the house structurally. Sealing these cracks will reduce the risk of water penetration, which could freeze and expand during the winter and cause the cracks to enlarge.

Corrected -
builder punch
list

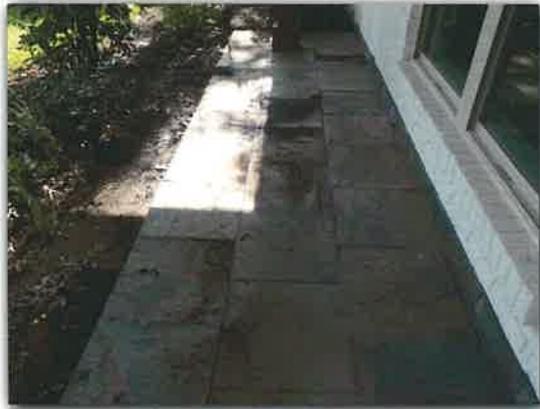
The front porch appears to slope towards the house. This condition can promote moisture seepage. Unfortunately, it is difficult to improve this situation without resurfacing the porch adjacent to the house.

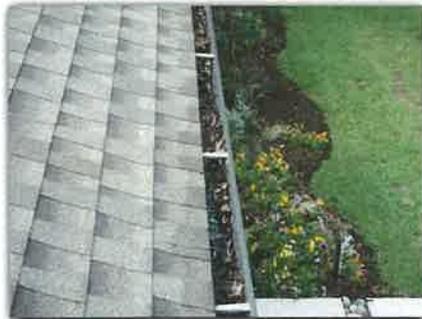
Need to remove the debris from the gutters.

Corrected -
checked
monthly

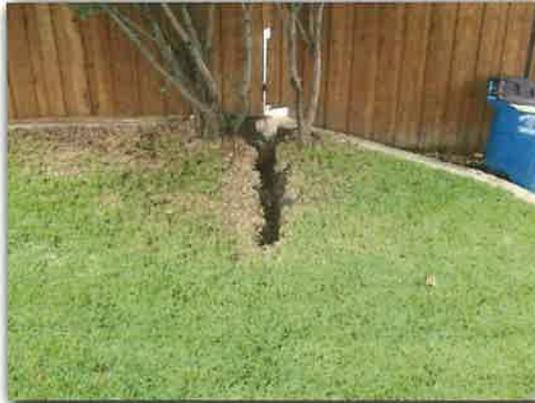
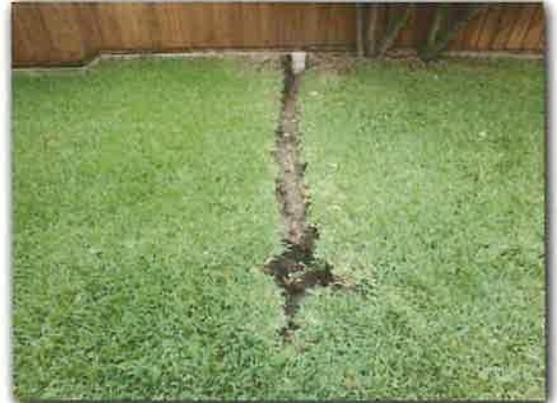
The trenches in the back yard need to be filled as they are a trip hazard.

Corrected -
builder
punch list

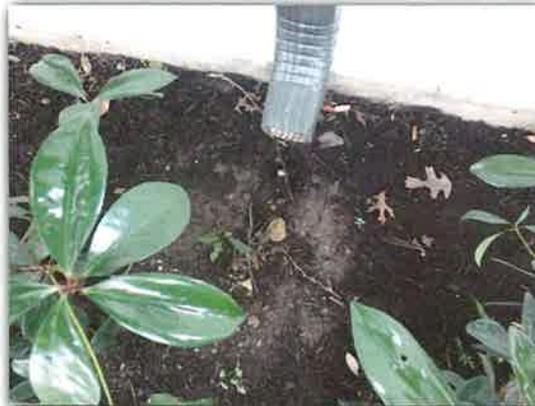
It is recommended that splashguards be installed at the bottom of each downspout.

Corrected -
brand new ones
installed 4/24

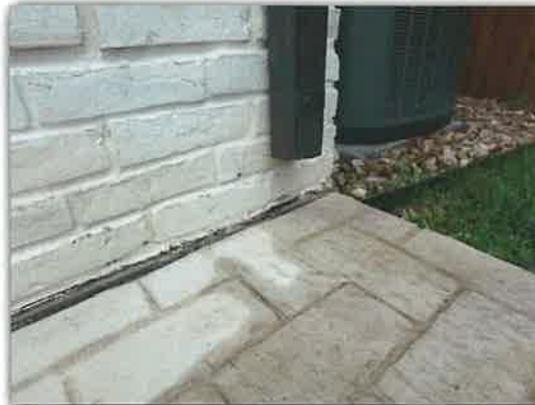
The bottom section of the downspout is missing at the southeast corner.

Corrected -
builder
punch list

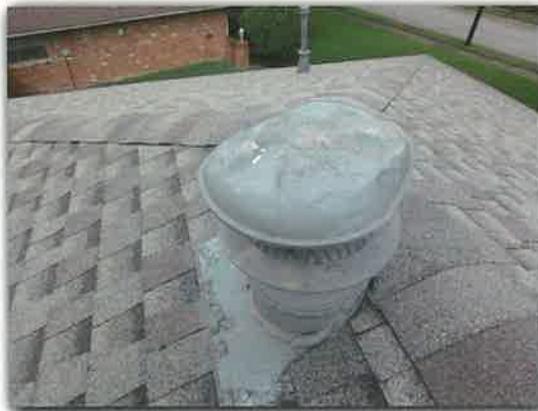
There is evidence of previous hail at the exhaust and vent caps. There is however no visible evidence of hail at the shingles. It may be the shingles were previously replaced but the exhaust and vent caps reused. No repairs are deemed necessary at this time.

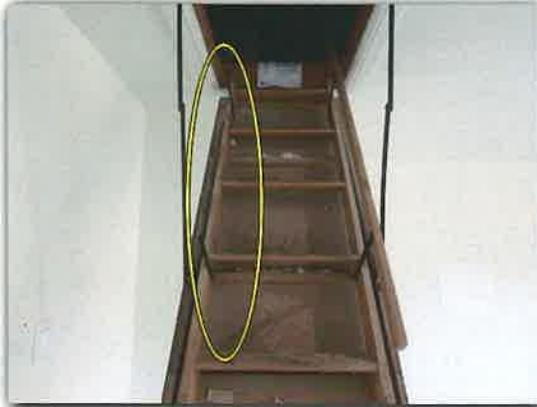
One of the stair railing handles is missing at the attic stairs in the garage.

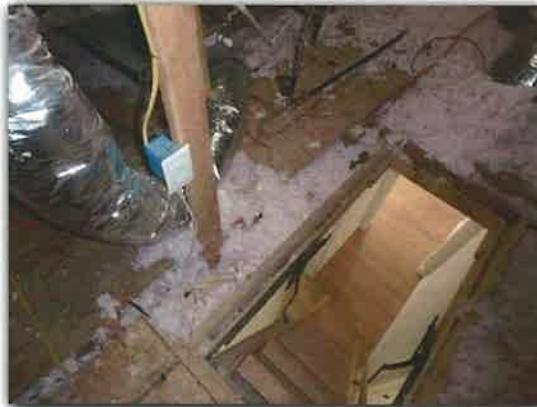
There should be a 2 foot wide floored path from the attic access stairs to the furnace and a/c units in the attic. Additional flooring is needed to cover the void(s) in the existing flooring.

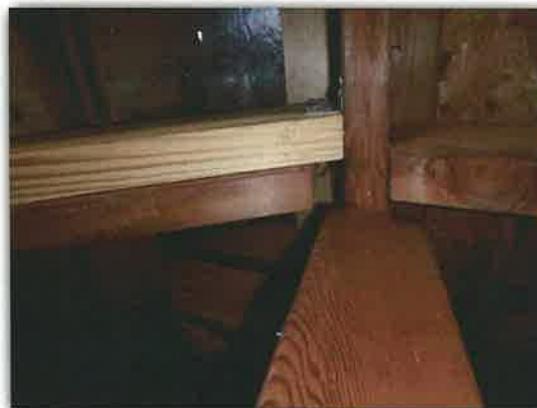
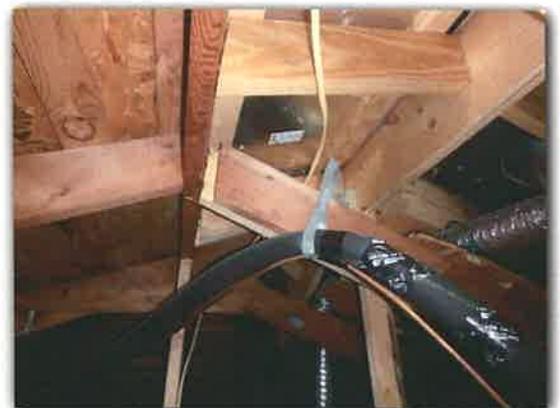
Improvements and modifications were observed in the attic.

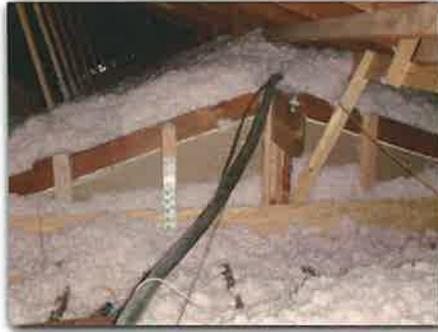
Insulation needs to be installed at the attic walls that are adjacent to living areas.

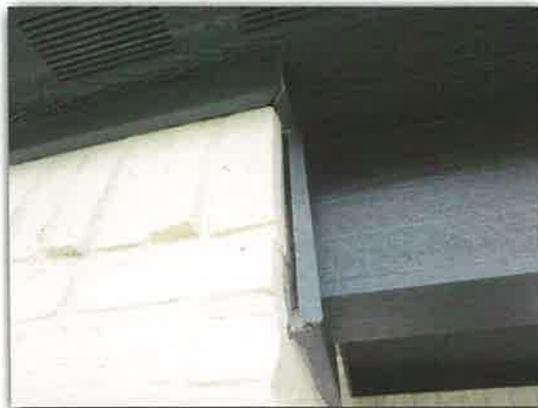
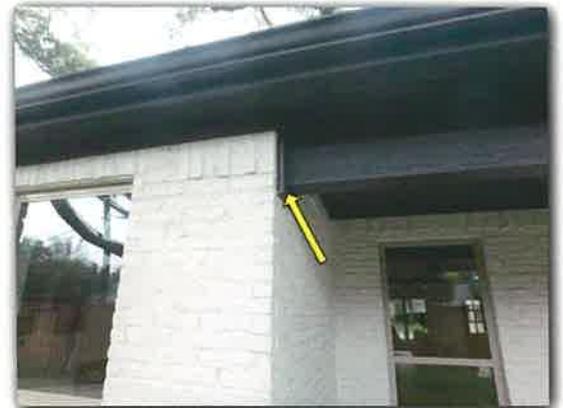
Need to securely fasten and seal the trim boards at the back porch.

Corrected -
builder punch
list

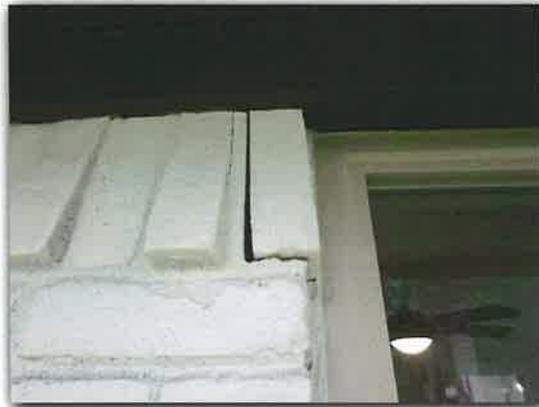
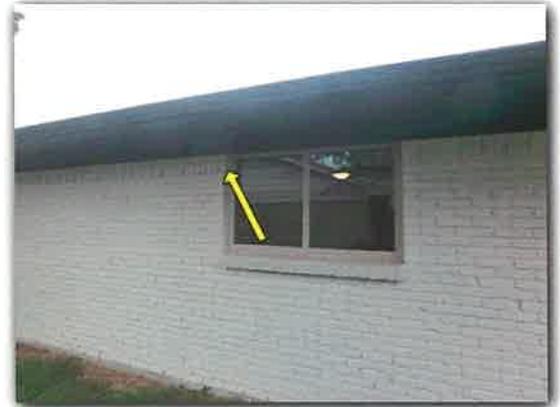
Need to patch the mortar at the top of the east wall.

Corrected -
milder punch
list

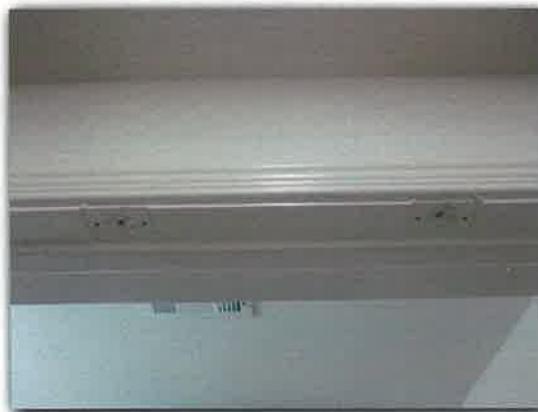
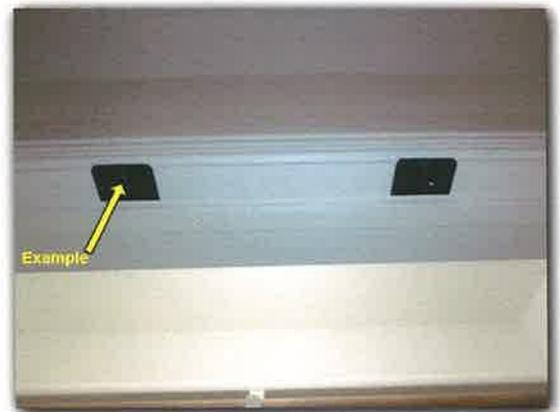
The strike plates are missing at the top of the master bathroom closet doors.

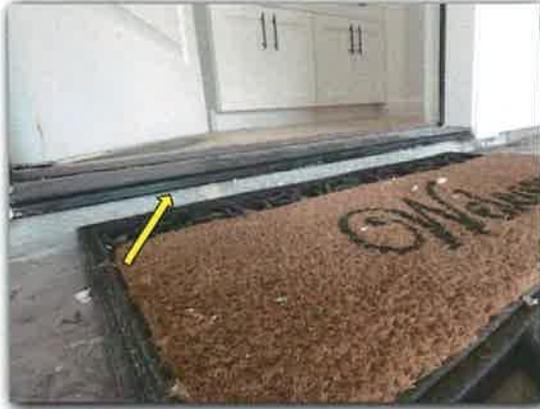
Some type of support needs to be installed below the threshold at the garage door.

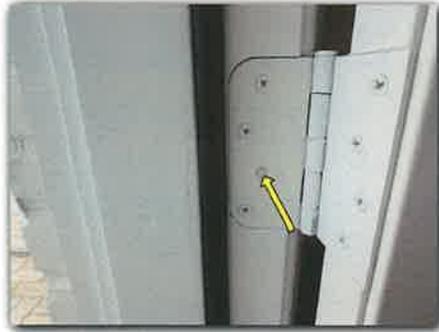
Screws are missing at three of the hinges at the master bedroom doors to the exterior.

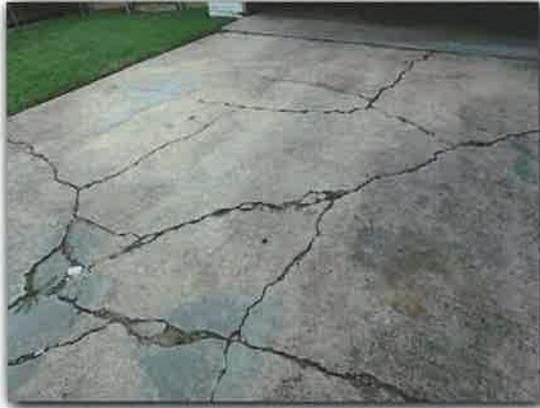
Need to patch the cracks in the driveway to prevent water from penetrating, which could result in soil expansion below the driveway and further damage.

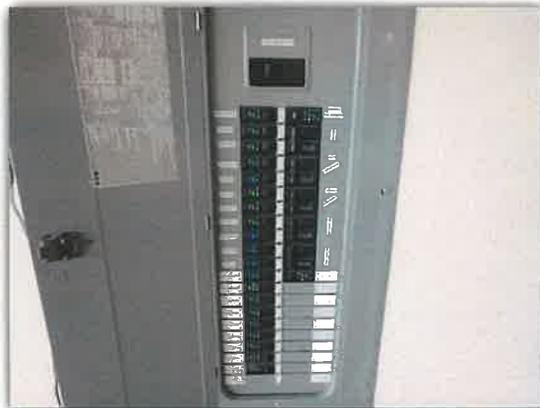
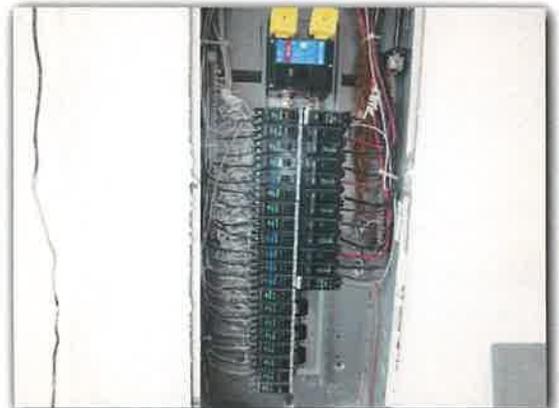
Some of the breakers are not labeled properly. The west bathroom and master bathroom outlets, and the exterior outlets are connected to the outlet labeled "Dishwasher".

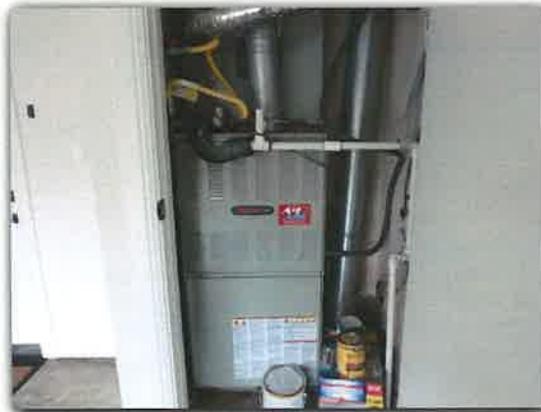
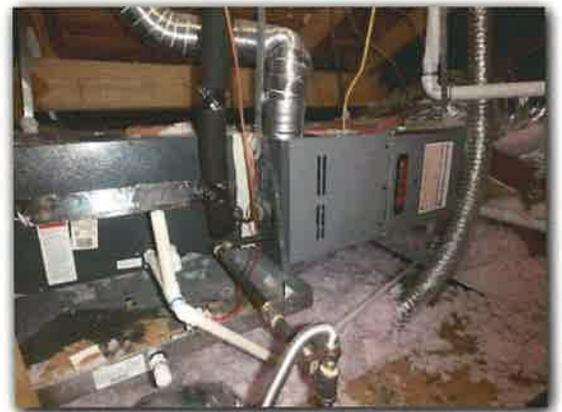
It is recommended that a screen covering be installed at the ceiling of the furnace closet to reduce the risk of insulation falling into the closet and/or rodents from entering the closet.

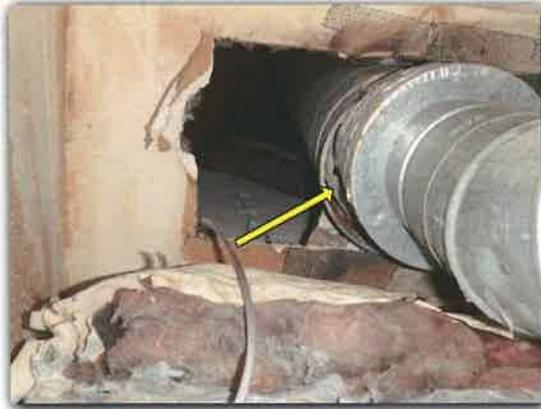
A portion of the furnace exhaust pipe is disconnected in the garage.

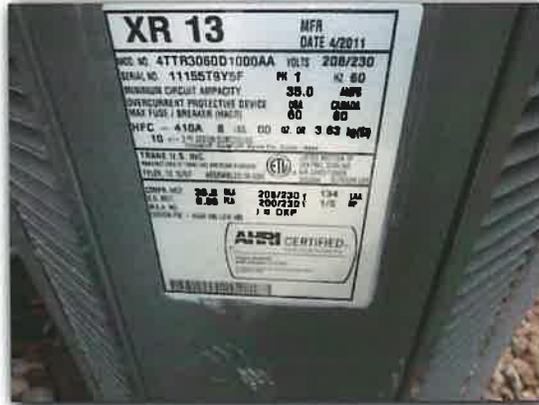
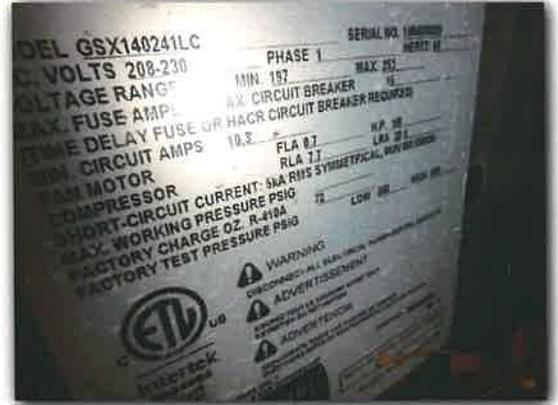
The intake air at the master bedroom unit registered 70 degrees. The output air registered 60 degrees.

The intake air registered 70 degrees. The output air registered 57 degrees.

The temperature drop measured across the evaporator coil of both air conditioning systems is less than considered typical. There should be at least 15 degrees difference in the intake and the output air. This usually indicates that servicing is needed. A qualified heating and cooling technician should be consulted to further evaluate this condition and the remedies available for correction.

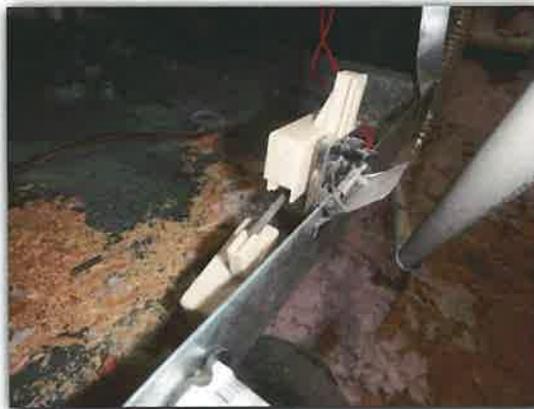
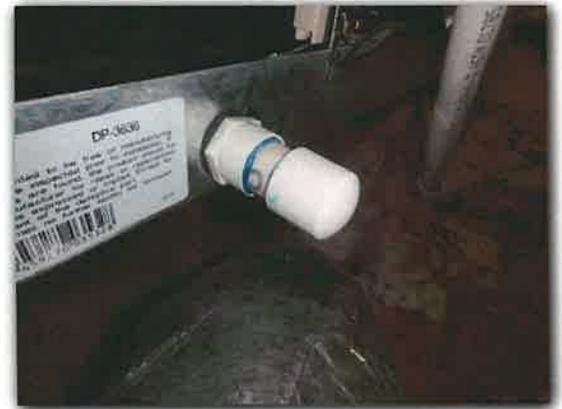
Need to remove the insulation from the drip pan under the a/c units in the attic to reduce the risk of the secondary drain pipe from becoming clogged and allowing water to overflow and penetrate the structure.

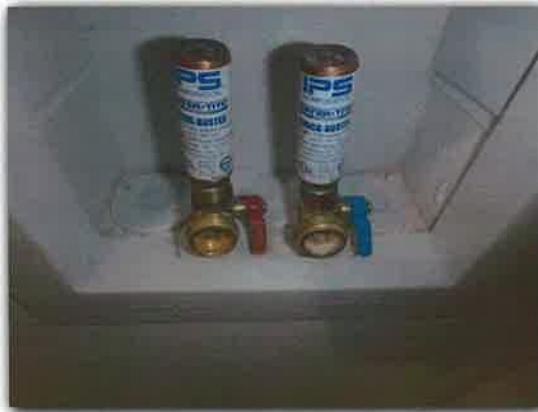
I could not inspect the water supply to the washing machine connections as the drain plug has not been removed.

Corrected -
inuder punch
list

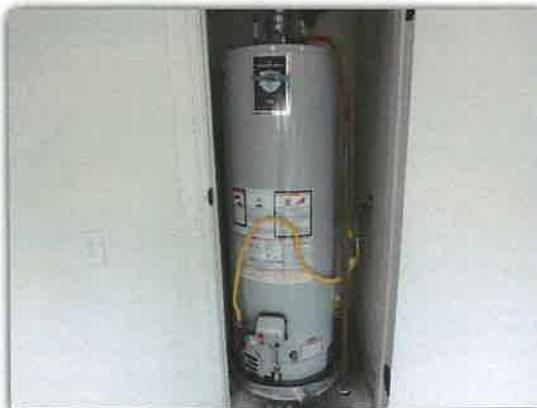
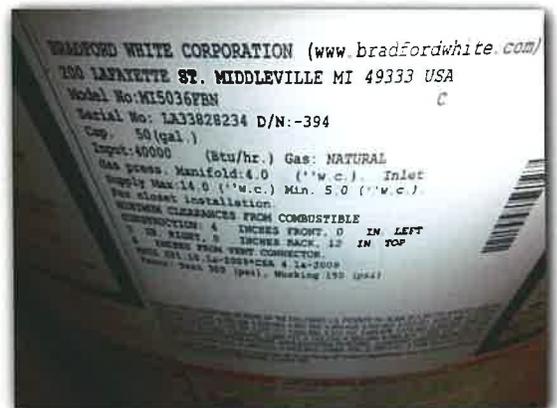
It is recommended the pipe connected to the drip pan beneath the water heater discharge to the lower level of the garage floor to prevent water intrusion into the house in the event water discharges into the pan.

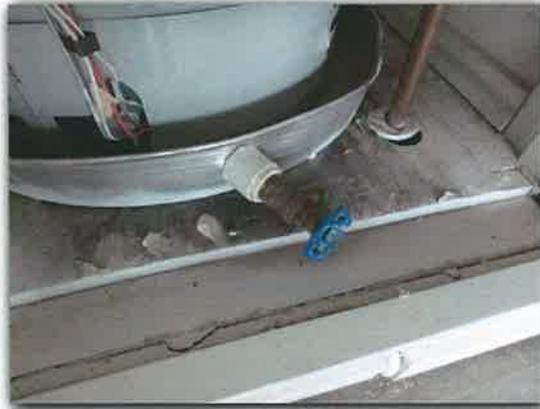
The supply of combustion air (and draft air) for the water heater may be insufficient. When combustion air is required, two openings are normally required. One should be located within the uppermost twelve inches of the enclosure and the other within the lower twelve inches of the enclosure. This condition represents a health hazard that should be further investigated by a Licensed Plumber and repaired as necessary.

It is recommended that a screen covering be installed at the ceiling of the water heater closet to reduce the risk of insulation falling into the closet and/or rodents from entering the closet.

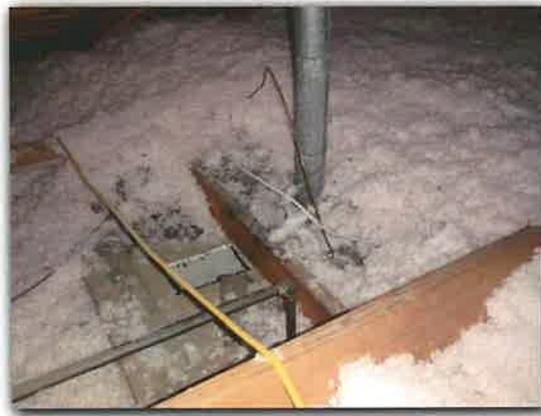
The insulation should be cleared away from the water heater exhaust flue in the attic. At least a 1 inch clearance is recommended between exhaust flues and combustible materials.

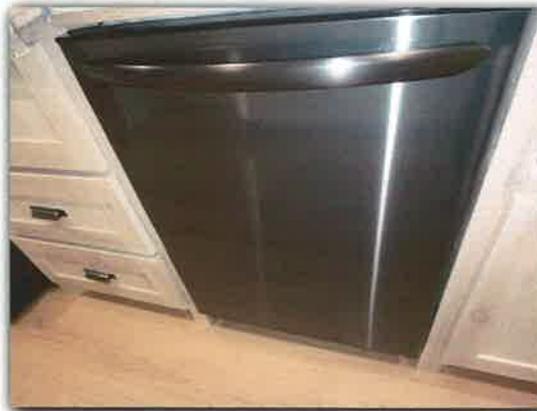
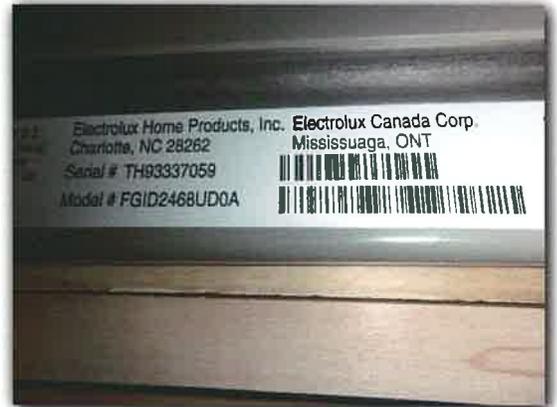
The dishwasher soap door did not open as intended when the unit was operated.

Dishwasher
replaced
7/20

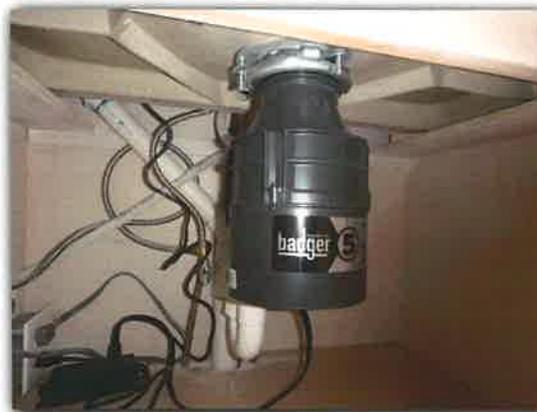
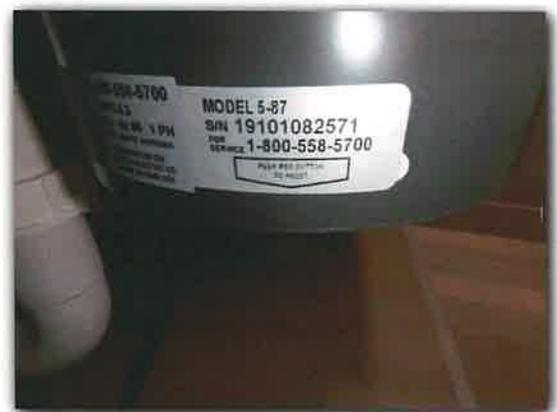
The vacuum switch is not working at the disposal.

corrected -
inuder
punch
list

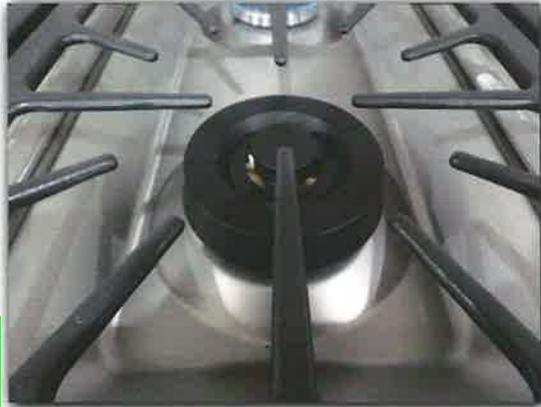
The front middle burner is not working properly and should be further evaluated.

Corrected -
inuder
punch
list

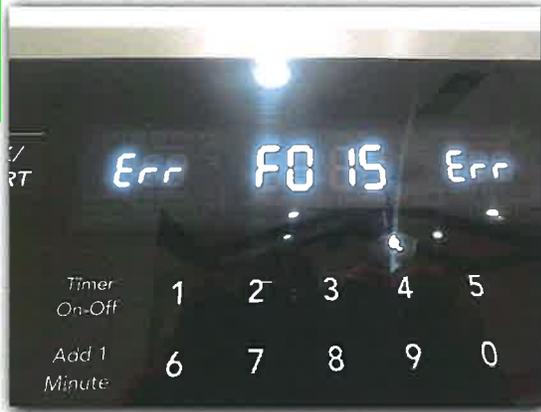
The ovens are not working properly. An Error Code was displayed.

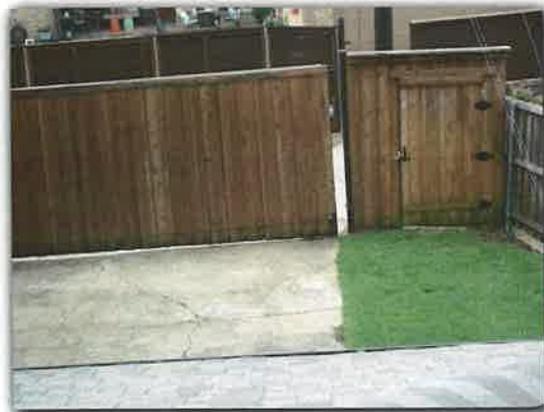
The travel needs to be adjusted to completely close at the driveway gate.

Corrected -
builder
punch
list
