PROPERTY INSPECTION REPORT

Concerning: 4803 MARCH AVE, DALLAS, TX 75209
(Address or Other Identification of Inspected Property)

By: Michael Killion, Lic #5389 01/02/2021
(Name and License Number of Inspector) (Date)

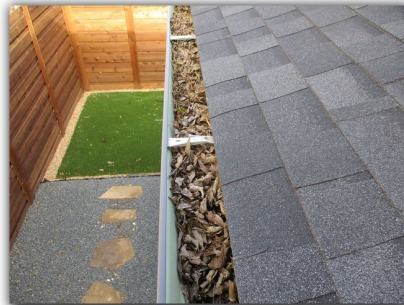
HOUSE APPEARS TO LACK POSITIVE DRAINAGE AT THE EAST, WEST AND NORTH. PER CURRENT STANDARDS, GRADING SHOULD GENTLY SLOPE AWAY FROM FOUNDATION A MINIMUM OF 6 INCHES WITHIN THE FIRST 10 FEET.

SOME OF THE GUTTERS ARE FULL OF DEBRIS .

*There is a new (2022) grass dog run on the west side of the house which slopes away from the house at approximately 10 degrees.

Gutters have been cleared of debris. And there are drainage catch basins on all sides of the house.

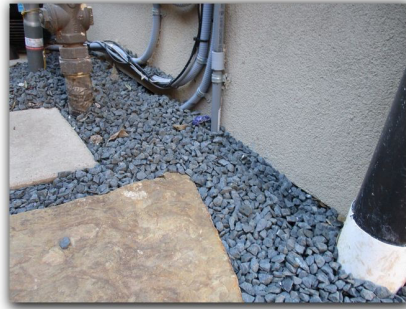
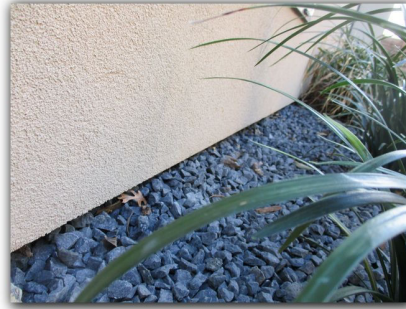
SOIL TOO HIGH CONDITIONS ARE PRESENT ALONG BOTH SIDES OF THE N/E CORNER OF THE HOUSE. UNDER PRESENT STANDARDS THERE SHOULD BE AT LEAST 4 INCHES OF FOUNDATION VISIBLE BELOW BRICK VENEER AND 6 INCHES OF FOUNDATION VISIBLE BELOW ANY SIDING / STUCCO.

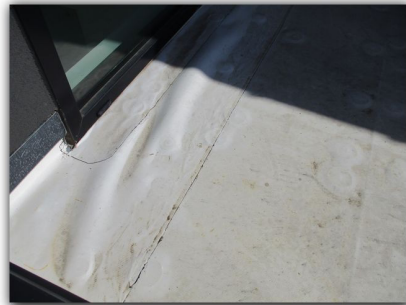
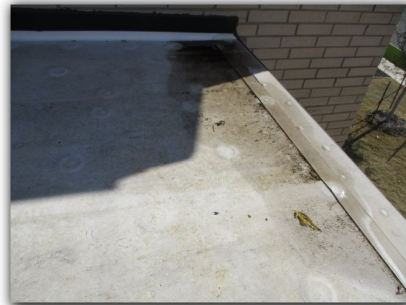
HOWEVER: THE POLY MEMBRANE ROOF COVER ABOVE THE FRONT PORCH IS BUBBLED; AND SHOWS SIGNS OF STANDING WATER THAT INDICATES IT IS NOT PROPERLY SLOPED TO DRAIN WATER.

NEED A QUALIFIED ROOFING CONTRACTOR TO FULLY EVALUATE THE ROOF AND MAKE ANY NEEDED REPAIRS.

***The poly membrane roof above the front porch was repaired in February 2021. No standing water.**

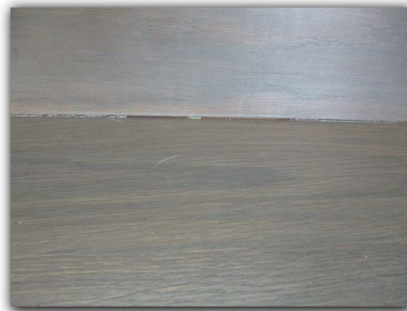
OBSERVED HAIRLINE CRACKS IN WALL AT THE CORNERS OF THE WINDOW IN THE DOWNSTAIRS GUEST BATHROOM.

CAULK REPAIRS NEEDED BETWEEN SOME OF THE STAIR TREADS AND RISERS = COSMETIC.

*Small cosmetic caulk and paint repairs have been done in March 2024.

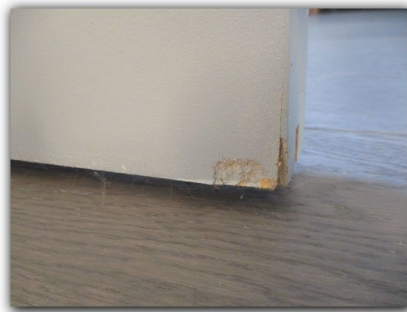
THE MASTER BATHROOM BARN DOOR IS CHIPPED AT THE BOTTOM HANDLE SIDE CORNER.

*This cosmetic doors chip was repaired in 2021.

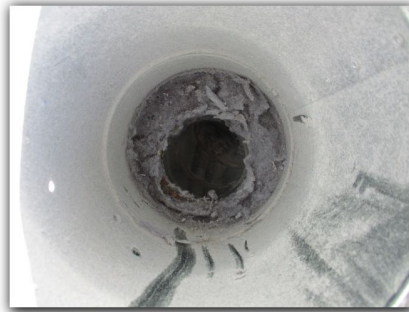
THE DRYER VENT HOOD ON THE ROOF LACKS A SELF CLOSING BACK DRAFT DAMPER.

THE DRYER VENT PIPE NEEDS TO BE CLEANED.
