PROPERTY INSPECTION REPORT

Concerning: 4231 Munger Ace Dallas, Texas 75204
(Address or Other Identification of Inspected Property)

By: S. CRAIG LEMMON License # 5885 August 8, 2020
(Name and License Number of Inspector) (Date)

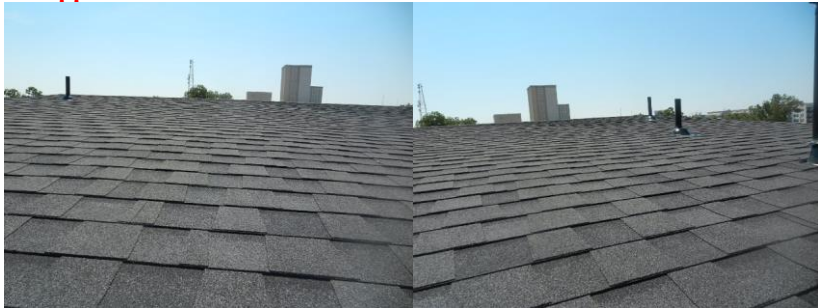
No upper roofline ventilation

Upper area has a gas HVAC system which requires primary/secondary fresh air

**** New ventilation was installed on roof prior to closing by builder. In addition, seller put in A/C venting from the ducts to control humidity and temperature in mechanical closet in 2020.**

I recommend that a qualified contractor be called to inspect and make any necessary repairs.

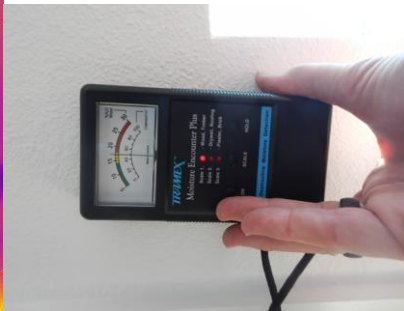
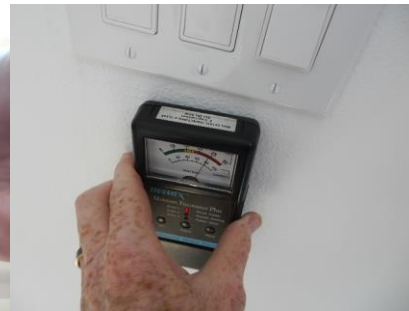
INTERIOR/ Evidence of previous repairs.

Wet wall at the second floor under the shower that leaked

High moisture reading on the second-floor front wall switch area under the third-floor shower area that leaked

**** Repaired by builder prior to closing. Drying out for 48 hours plus repainting, repairing any baseboards.**

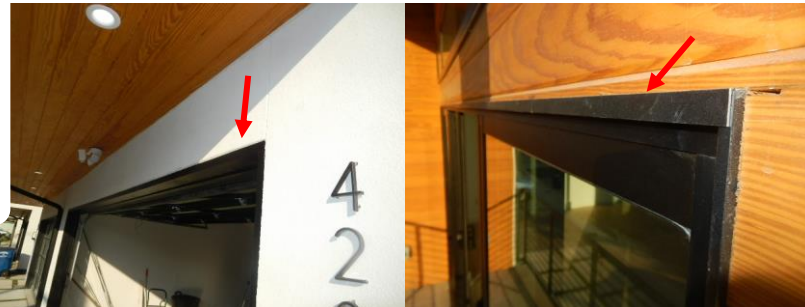
EXTERIOR/ Under construction
May be the responsibility of the HOA
Flashing missing at but not limited to:
Garage door
Doors windows

** Seller routinely checks areas and has sealed tongue and groove wood while also caulking areas as needed.

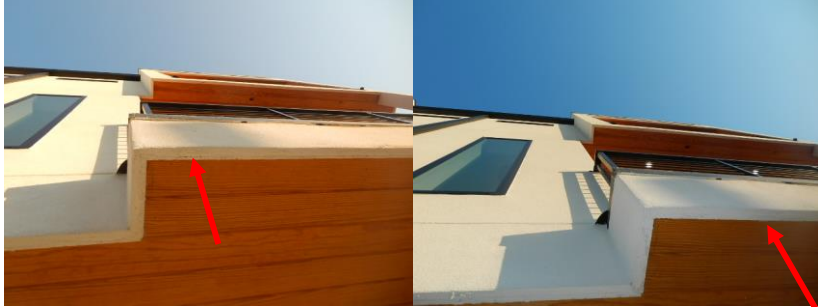
No visible weep holes on the lower bases of the structure and balconies

** Seller routinely checks areas and has sealed tongue and groove wood while also caulking areas as needed including cleaning stucco with cleaners.

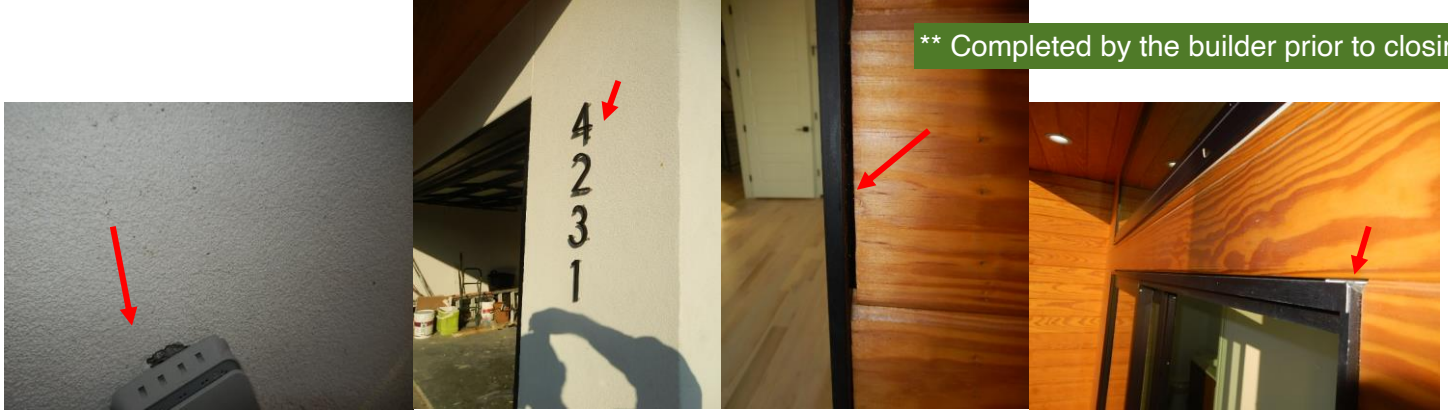
Seal the wall penetrations.

** Completed by the builder prior to closing.

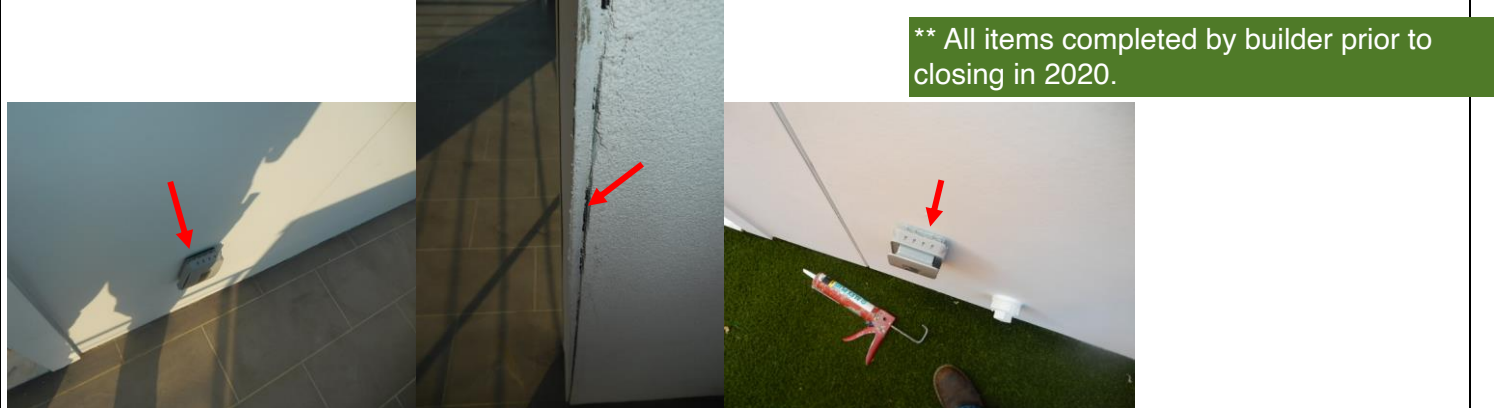
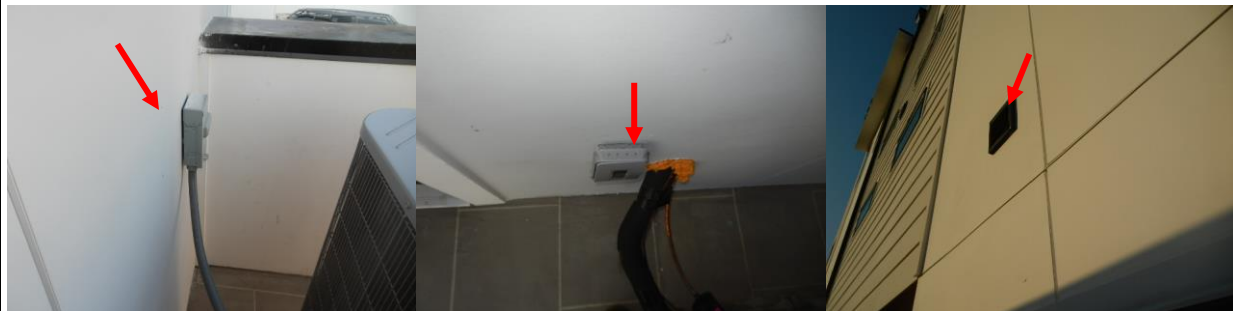
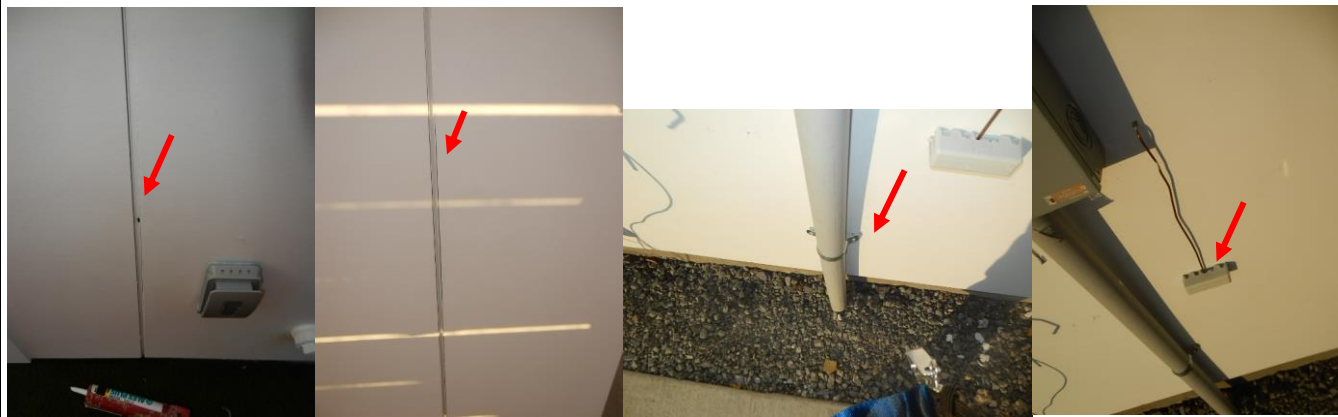
Gap between the stucco base metal drain and the foundation. Protect the substrate

**** All items completed by builder prior to closing in 2020.**

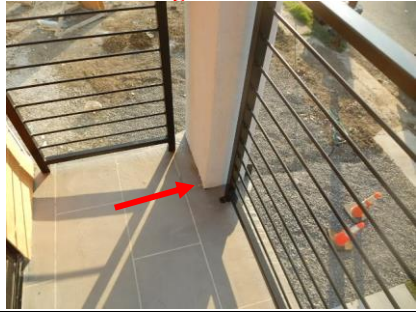
Stucco cladding should not be directly on the cement

** Seller routinely checks areas and cleans as needed.

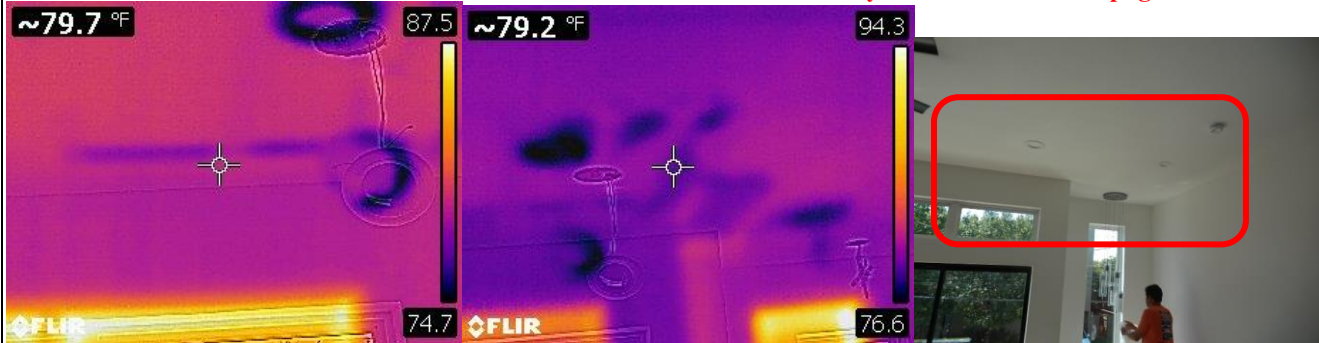
Leak

Leak at the third-floor front shower. Second floor front section and balcony areas had water seepage

** All items completed or repaired by builder prior to closing.

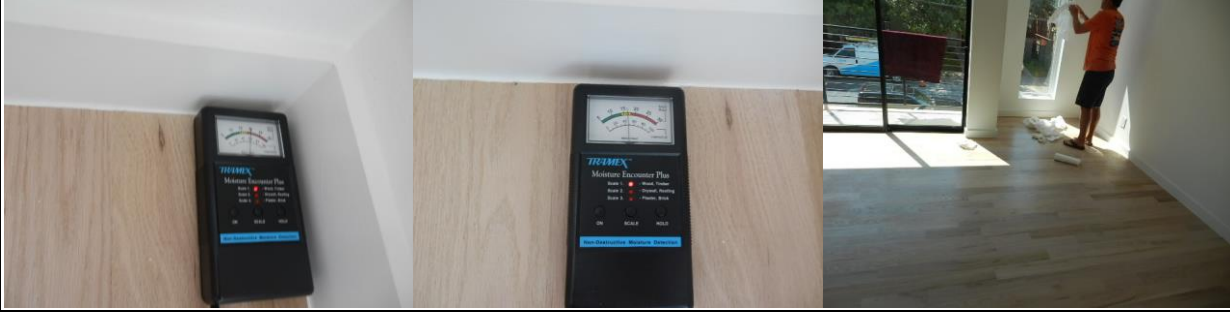
Elevated moisture reading at the second-floor area front corner after water leak

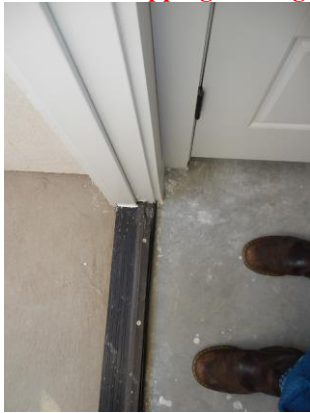
Weather stripping missing on the lower floor doors of the garage and exterior

**** Weather stripping and front door tread plate repaired by builder prior to closing.**

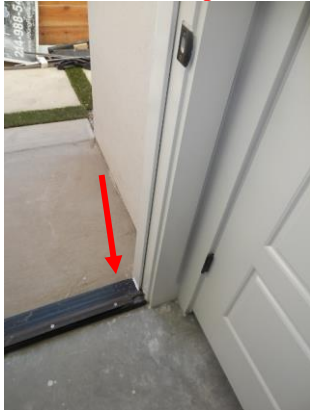
Front door tread plate is damaged

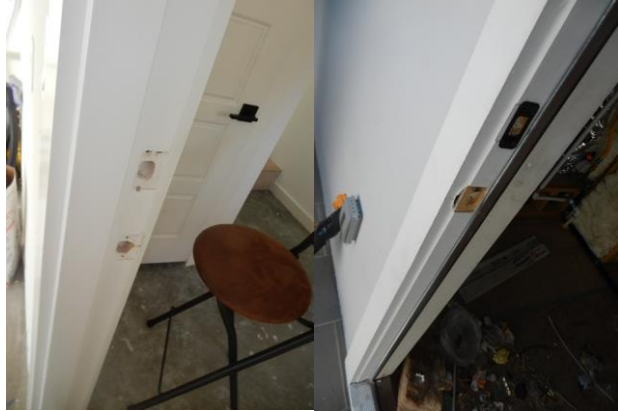
**Door hardware to the garage is missing
Door hardware at the upper HVAC room**

**** Door hardware repaired by builder prior to closing.**

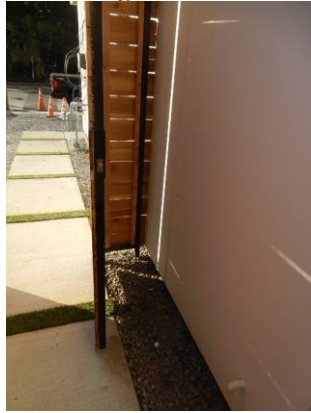
**Doorstops are missing or in need of repair throughout the structure.
Entrance gate**

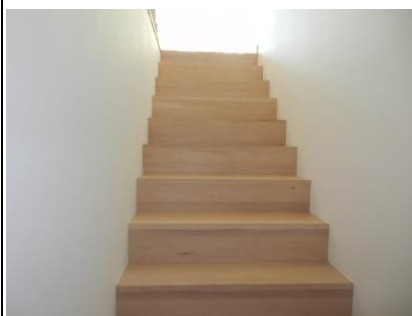
Handrail missing from the first to second floors

Handrails must terminate into the wall or to a post

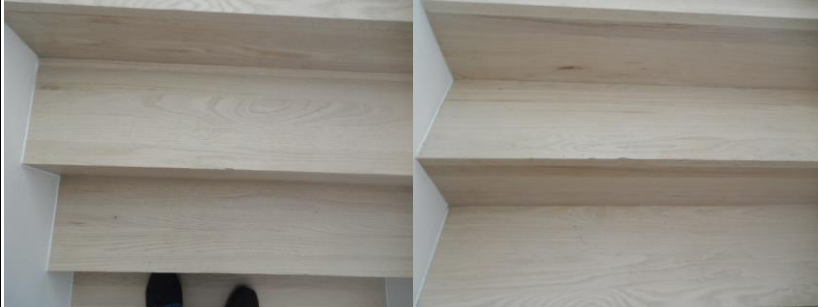
Damaged stairs on the first to second floor

** Damaged floors repaired

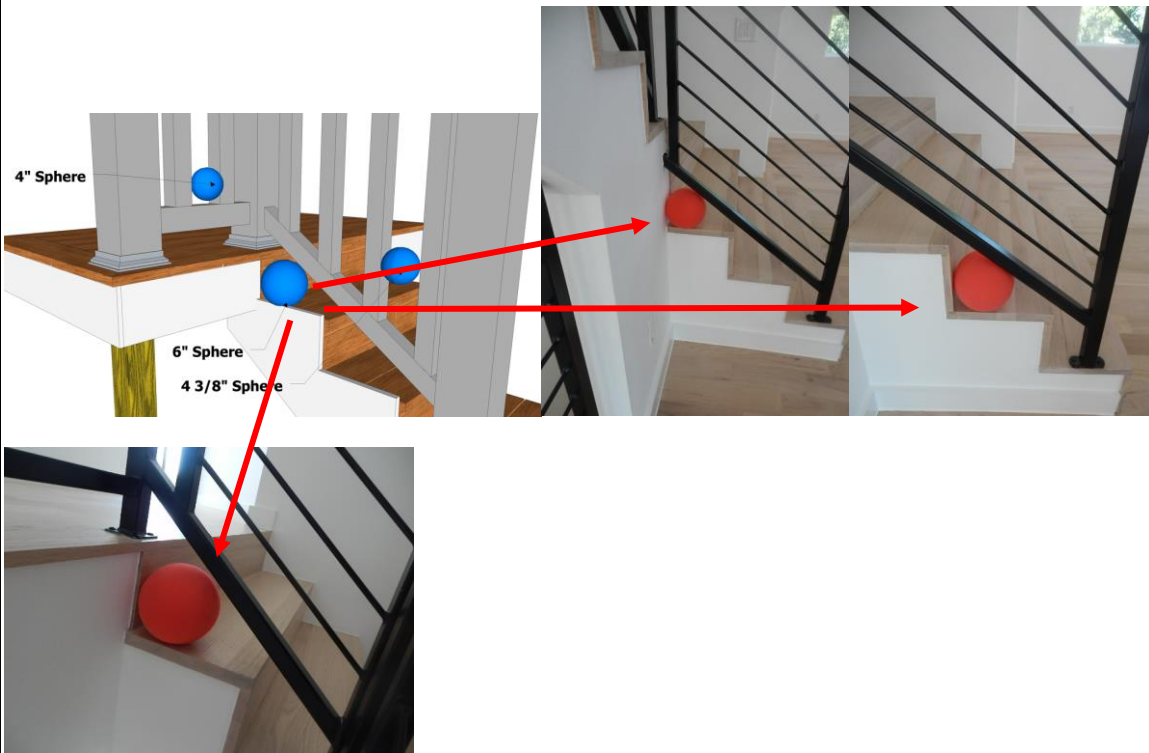
6 in sphere fits under the railing at the second to third floor staircase

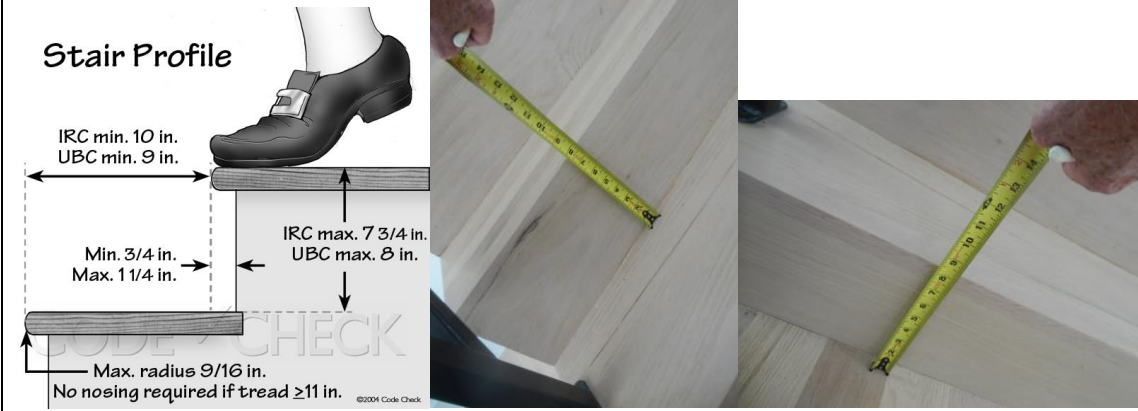
Step height is above the maximum height allowance of 7 3/4 inches

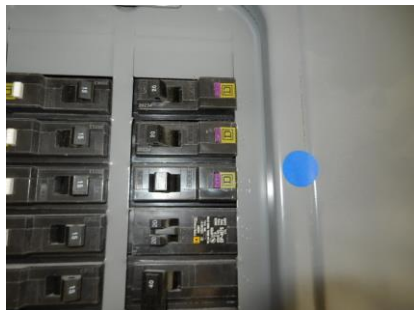
Bathroom GFCI breaker does not reset

**** Gaps and GFCI repaired by builder prior to closing.**

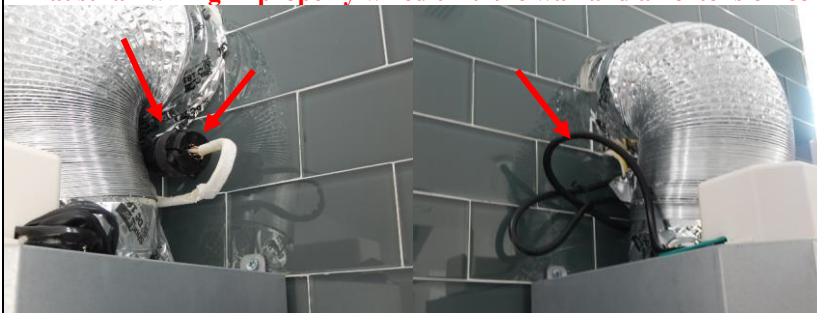
Exhaust fan wiring improperly wired thru the wall and an extension cord plug in with exposed wiring

Seller purchased new vent hood and cabinet post closing to repair noted issues.

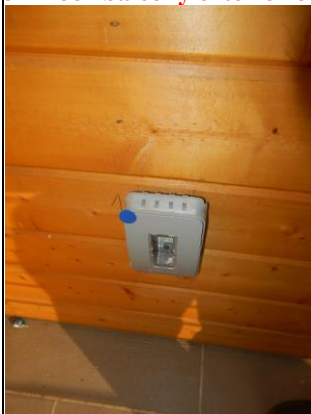
3rd floor balcony exterior outlet is not GFCI protected

** Builder repaired prior to closing.

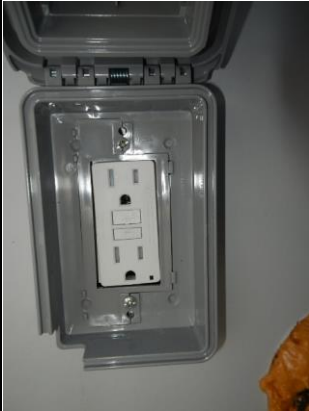
Exterior outlets must be identified as weather resistant WR type outlets which these are not

** All items completed or repaired by builder prior to closing.

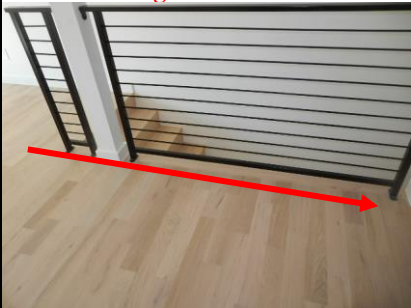
Receptacles shall be installed so that no point measured horizontally along the floor line in any wall space is more than 6 feet from a receptacle (E3801.2.1). Receptacle spacing exceeding the spacing requirement include but not limited to:
Outlet missing on the second-floor railing

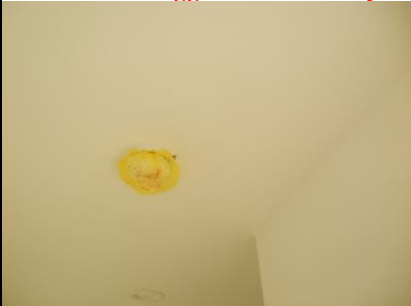
Smoke detectors: **Not tested as this is an end unit of a larger builder and unknown if testing would activate other units**
Some stilled bagged. Low battery chirping

** Smoke detectors repaired by builder prior to closing.

I recommend that a unit be installed in each bedroom and hall and that they be inter connected.

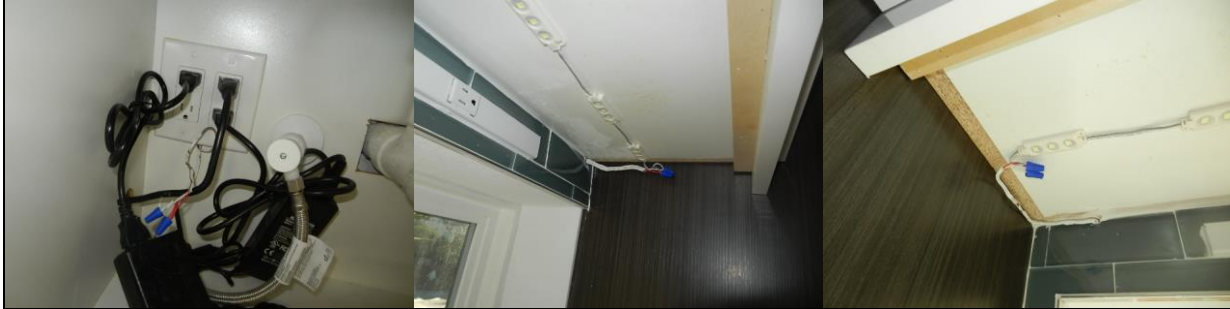
Low voltage wiring. In the kitchen cabinet, this should be protected from being hit or uncapped

**** No issues with unit. If battery supply unit needs to be replaced, it can be ordered off Amazon.**

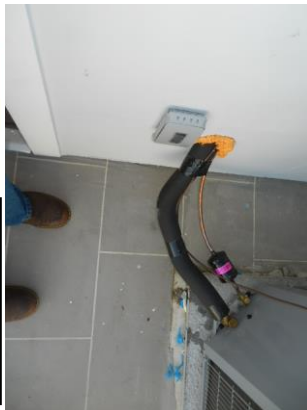
Protective coating required on refrigerant piping insulation per state-mandated 2015 IECC. Current regulations require locks on the freon lines (2009 IRC)

2013 IECC Code and Commentary
This section requires protection for piping insulation at all exposed exterior locations. The piping insulation must be protected from weather, moisture, and other external factors that may cause the insulation to deteriorate or become damaged. It is recommended that the insulation be protected with a protective coating that is UV resistant and meets the requirements of the IECC.

**** HVAC completed or repaired by builder prior to closing.**

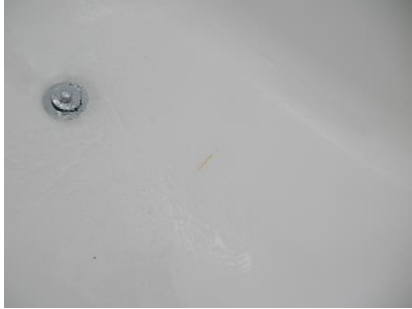
Leak at the third-floor front bathroom tub area

Rust in the third-floor front bathroom tub

**** Bathtub and Kitchen items were completed by Builder prior to closing in 2020.**

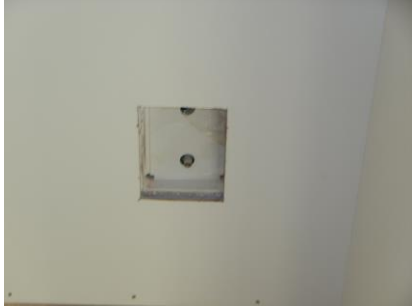
Kitchen refrigerator waterline is not complete

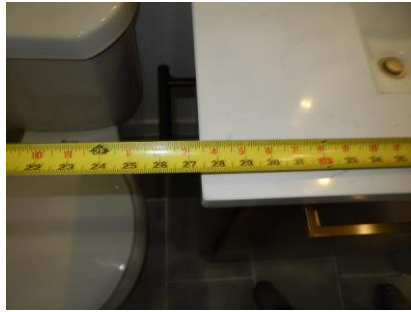
2nd floor Bathroom toilet has been set at less than the minimum requirement of 30 inches of clearance

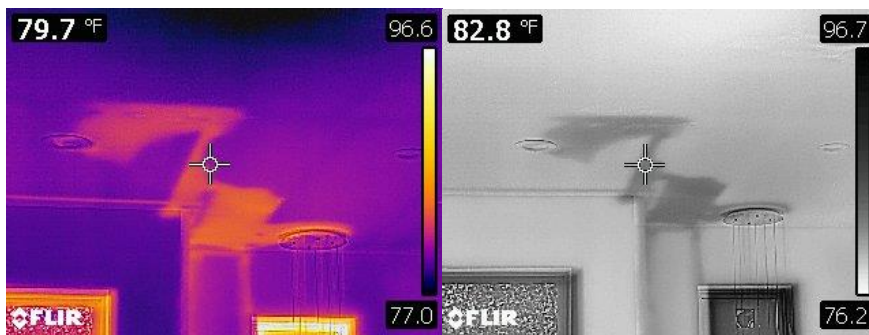
Third floor front bathroom shower/tub leaked when tested

**** Third floor leak was corrected by Builder prior to closing.**

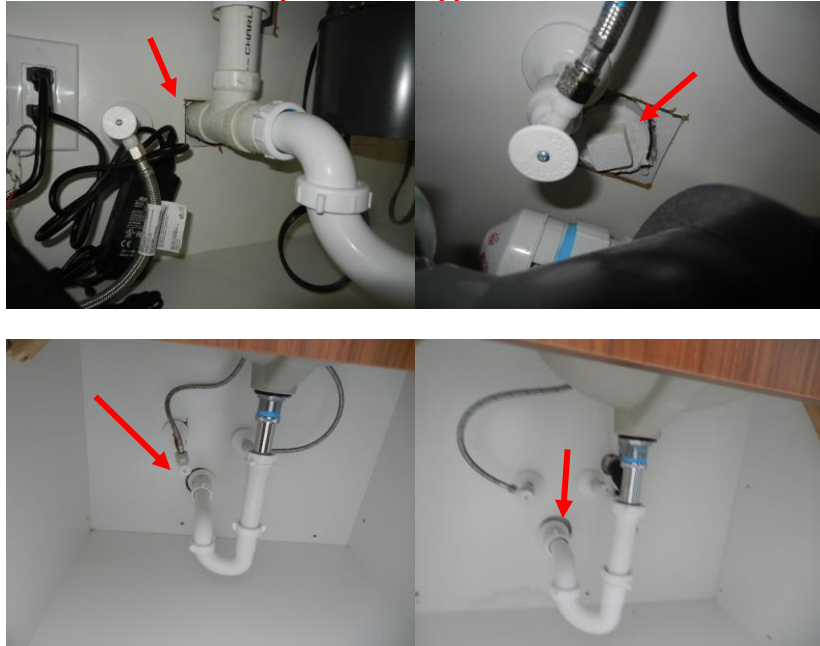
**Escutcheon plates missing at the kitchen sink
Under sized escutcheon plates in the upper bathroom**

I recommend that a licensed plumbing company be called to inspect and make any necessary repairs.
